# **Mechanical, Electrical, Plumbing Report**

**NEEDHAM TOWN HALL  
EXISTING CONDITIONS REPORT  
MECHANICAL, ELECTRICAL & PLUMBING SYSTEMS  
OCTOBER 1, 2007**

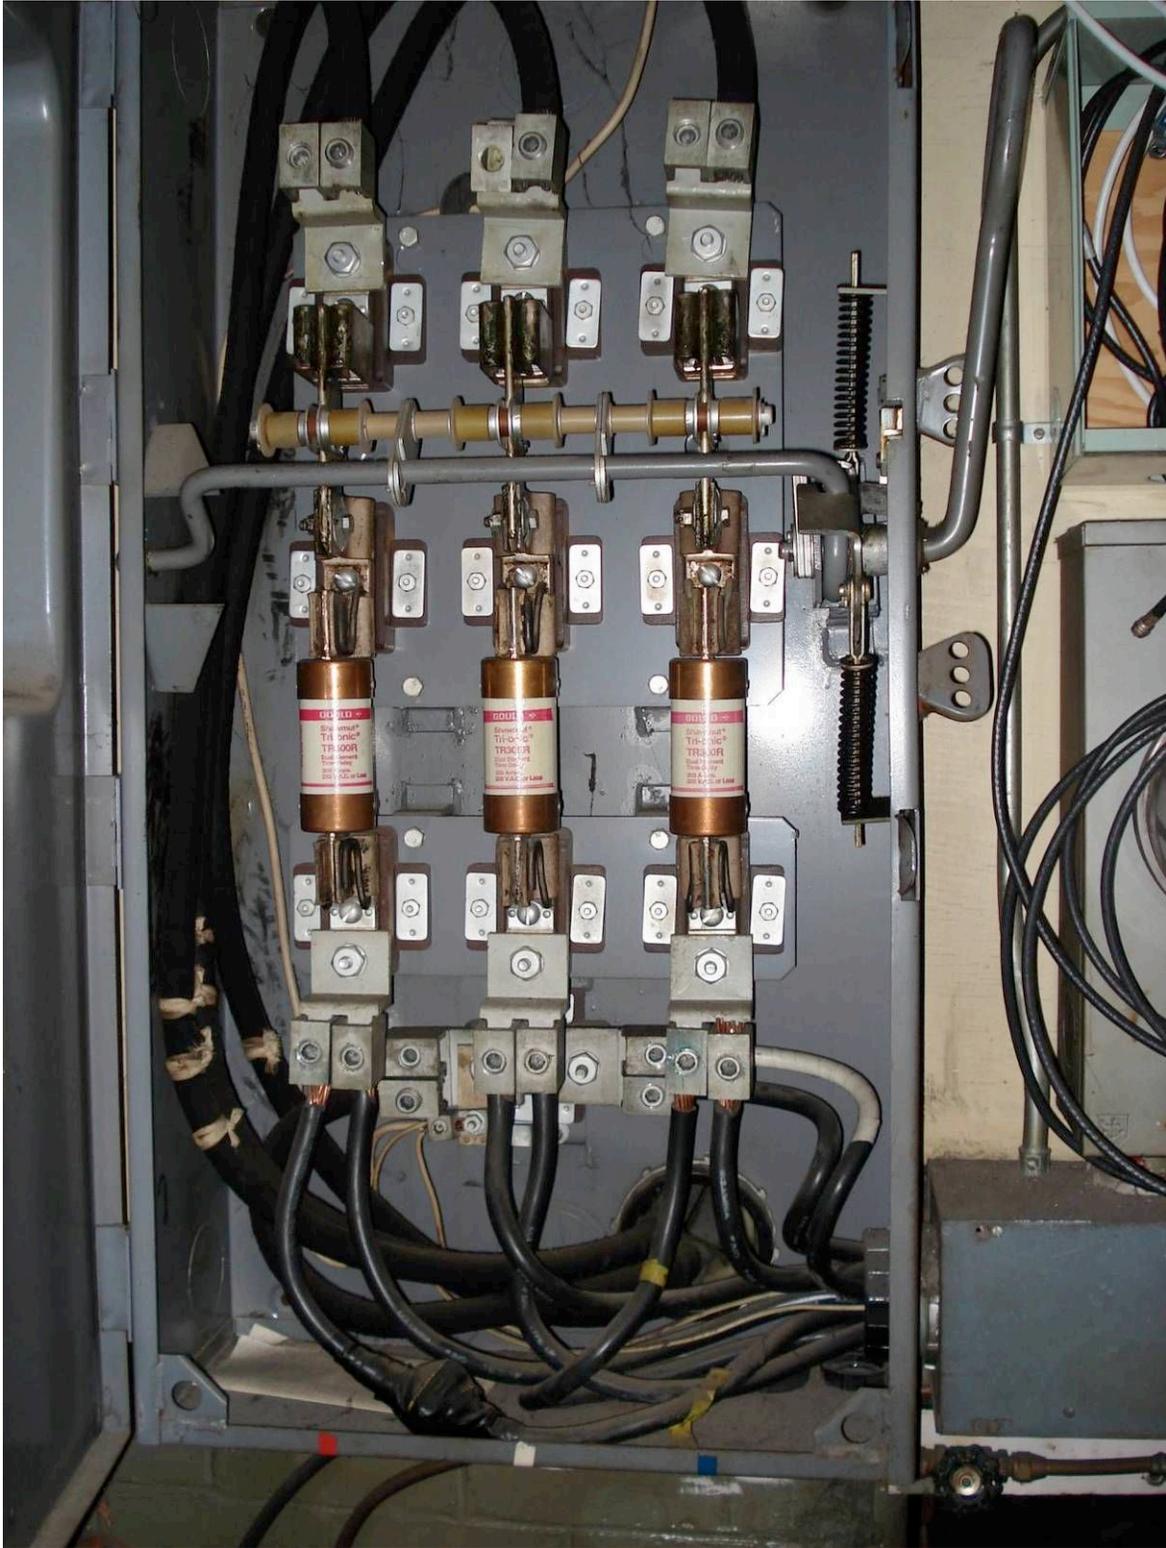
400A FUSED MAIN DISCONNECT

The building is currently fed from a small pad mounted NSTAR owned transformer located on the Chapel Street side of the rear parking lot. The service is rated at 120/208V three phase, four wire. There is one, four inch conduit that enters the building underground. The conductors terminate in a Square D 400A fused disconnect. There are three 300A Gould Shawmut Tri-onic Dual element time delay fuses within the fused switch. Within the fused switch, the #6 AWG CU ground wire is not properly identified as a ground, it is white not green as required by code . Also where the ground wire from the water service enters the fused disconnect, the knockout has come loose and slid down the wire. The loose knockout is resting just above the live terminal on the back of the fuse switch. The switch is making a rather load humming noise which may be cause by a loose connection or the knockout vibration against the fused disconnect. Power would need to be turned off by NSTAR at the transformer to properly inspect the fused

disconnect. There is one set of four Aluminum cloth covered conductors running from the transformer to the fused switch. We could not determine the size of these conductors. From the fused switch, two sets of 3/0 CU conductors run through two 200A meter sockets. One phase of one of these sets has been splice to extend its length about one foot. From these two meter sockets, one set of four 3/0 AWG CU conductors run to each of two separate three phase 200A panelboards. One of the 200A panelboards is a Bryant brand panelboard that appears, based on the date written on the panelboard cover, to have been added in 1984. The other 200A feed appears to feed a 200A Square D panelboard. It is very difficult to determine what circuit breaker feeds what loads because few circuit breakers are labeled. It appears that a second 200A Square D panelboard is fed from the first Square D panelboard. Due to multiple splicing of cables it was impossible to determine how the left hand Square D panel is fed. All three panelboard are close to or over the maximum height for a circuit breaker which is six feet, seven inches, (section 240.24). See attached photographs. This setup results in the town hall actually having two 200A three phase electrical services.

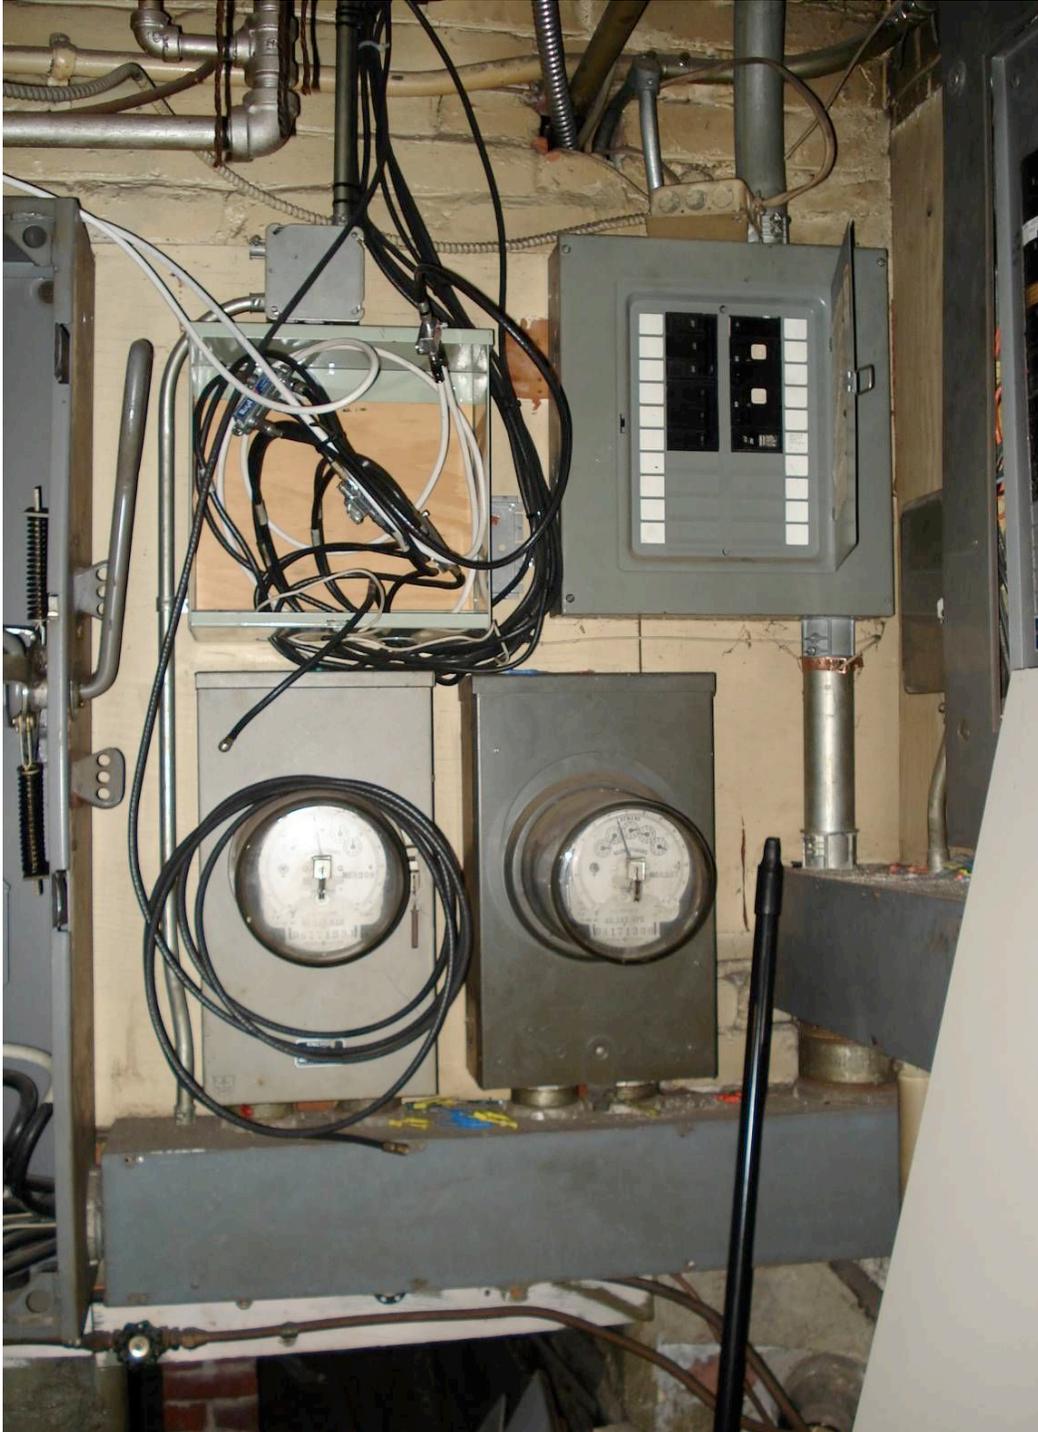
**TWO ELECTRIC METER AND BRYANT 200A PANEL FOR 1<sup>ST</sup> SERVICE**

We could not determine why the town hall has two, 200A services. Both are rated at 200A three phase, four wire. Both have close to the same demand, the left meter is at 32.5 kW and the right meter is at 33.5 kW. We have no way of knowing when these peaks reading occurred. If we assume they occurred at the same time, then the load on the town hall is in the range of 184A. This is well within the service capacity of the building. Due to age of the panels we did not remove all of the covers, however from what we did observe there are several panels still being fed with cloth covered wiring that is over 40 years old. Any renovations to the building will require a though examination of all the existing wiring.

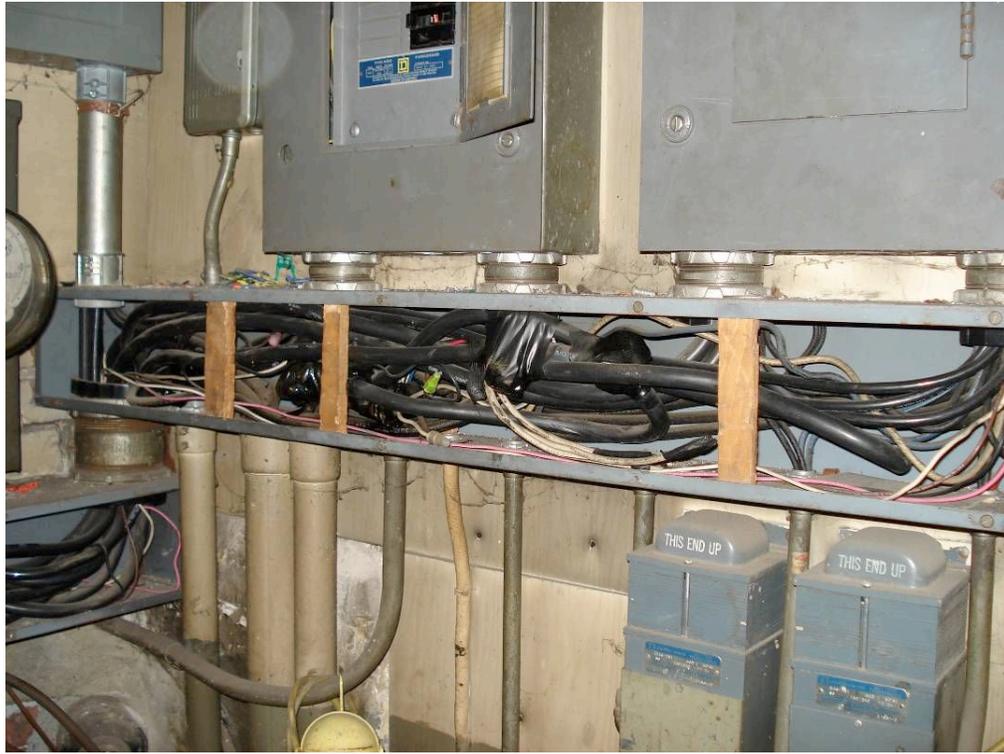
**WIREWAY UNDER MAIN PANELBOARDS**

In general the electrical system is not labeled at all. It is full of splices and taps, most of them not to code. Several of the splices appear to have gotten warm enough to cause the glue on the tape to form small puddles of black adhesive under some splices. See attached photographs.

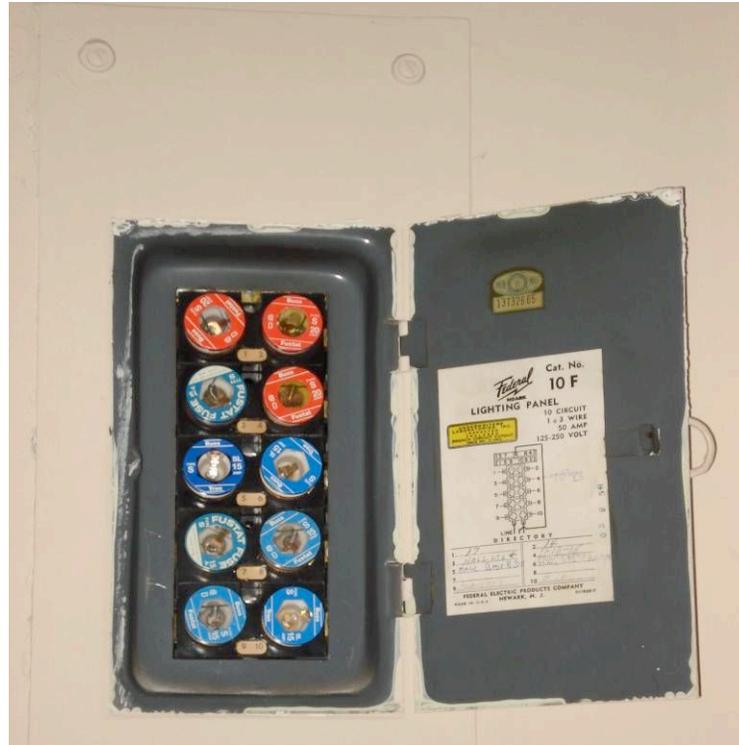
FIRST FLOOR FUSE PANEL

One the first floor there is one very old Federal brand fused electrical panel. This panel has 10 circuits is rated at 50A single phase. This panel appears to be close to, if not one of the original panels to the building. It feed hall lights and baseboard receptacles. On the second floor there are two electrical panels. The first panel is located in the Park and Recreation office. This panel is a Cutler Hammer 120/208V single phase 200A panel, with a 100A main circuit breaker. It appears that this panel feeds primarily receptacle and lighting loads. Based on the date within the panelboard, it appears that this panel was added in 1986. In the Vet's office there is a newer Murry brand 200A single phase panelboard with a 200A main circuit breaker. None of the main panels are capable of supporting a 200A branch circuit breaker. It is our belief that power for this panel is tapped off of the main feeders running from a meter socket to a Square D panel in the main mechanical room. This tap is not protected according to code. This panel was opened up to look for quality of installation and code violation. We found several National Electric Code (NEC) code violations: In pole positions 18 and 20 there are two single pole circuit breakers tied together with a sheet rock screw to feed the AC in room 21. The NEC does not permit sheet rock screws to be used to tie to single phase circuit breakers together to form a two pole circuit breaker. A factory made two pole circuit breaker needs to be used to feed a two pole (208V) load. The overall quality of the workmanship within the panel was fair. The wiring within the panel was not neatly

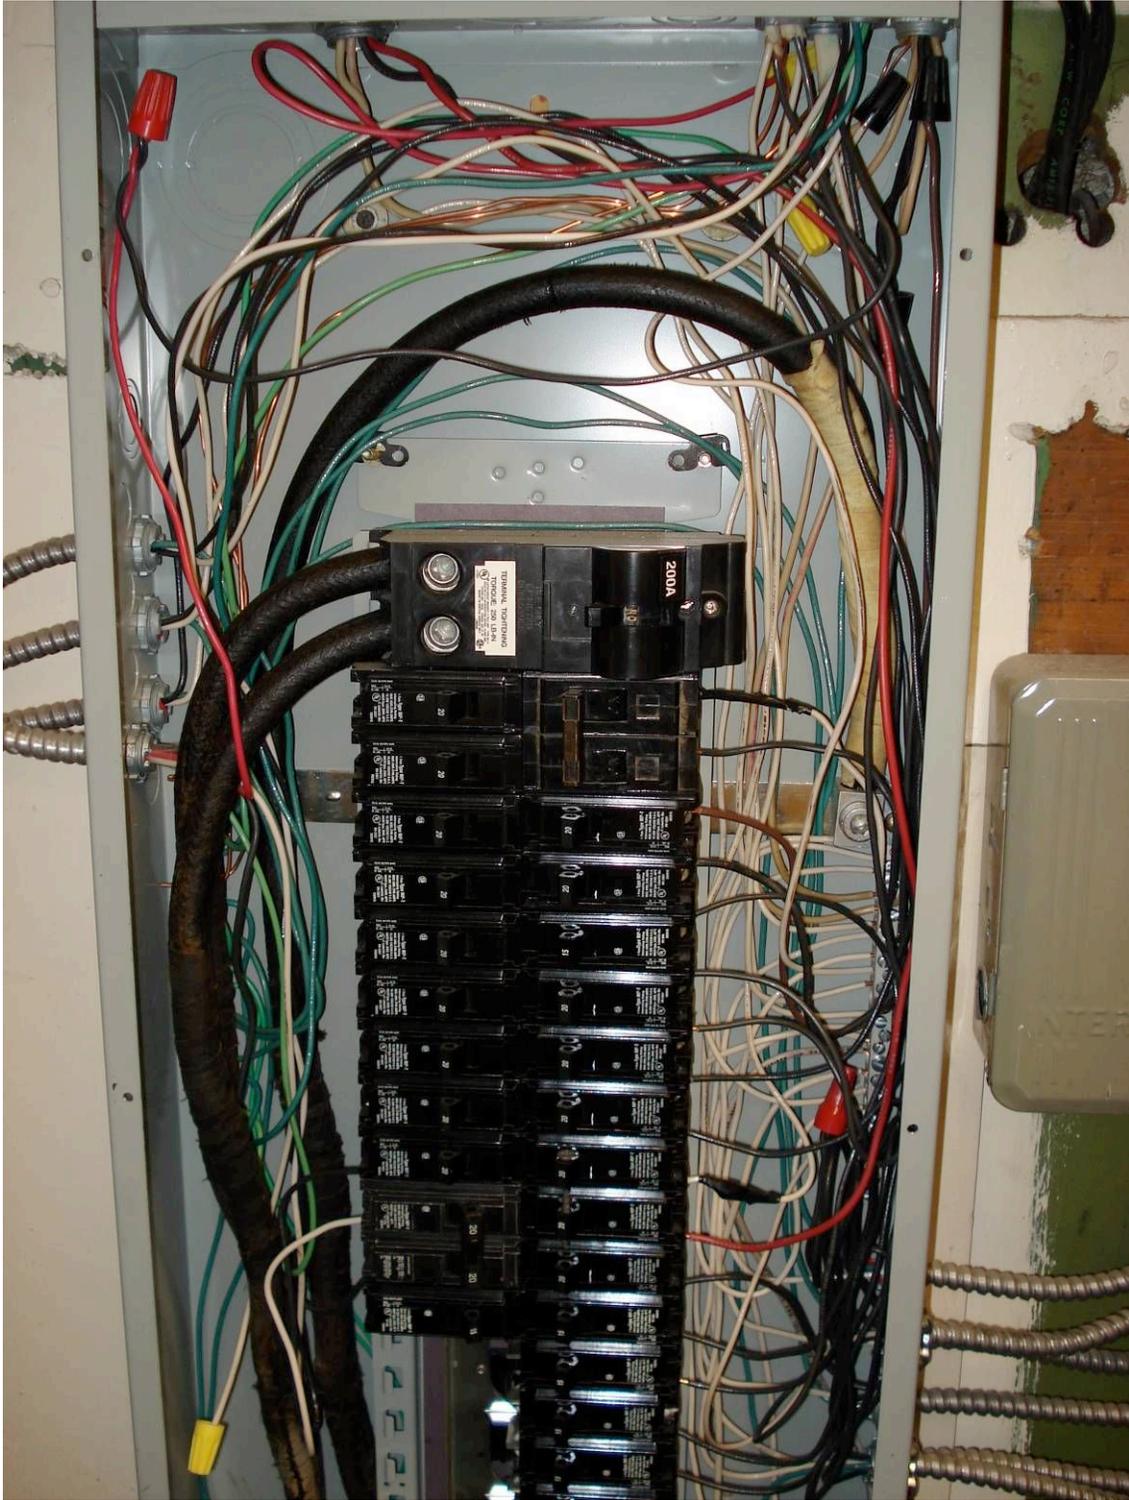
ELECTRICAL PANEL IN VETS OFFICE

dresses. In several location white conductors where used at hot wires instead of neutrals. In one instance the conductor was not marked at all, in two other cases the marking is not permanent as required by code (section 200.7). The neutral and ground busses are tied together which is not allowed by code except at the service entrance. Several branch circuits where installed utilizing type NM (Romex) cabling. Romex, under current code is not allowed above a dropped ceiling. Since the panel is located on the second floor which has a dropped ceiling, we can assume Romex should not be installed. Romex can also not be used in a place of assembly; therefore if it desired some time in the future to reuse the great hall, the use of Romex would need to be addressed.

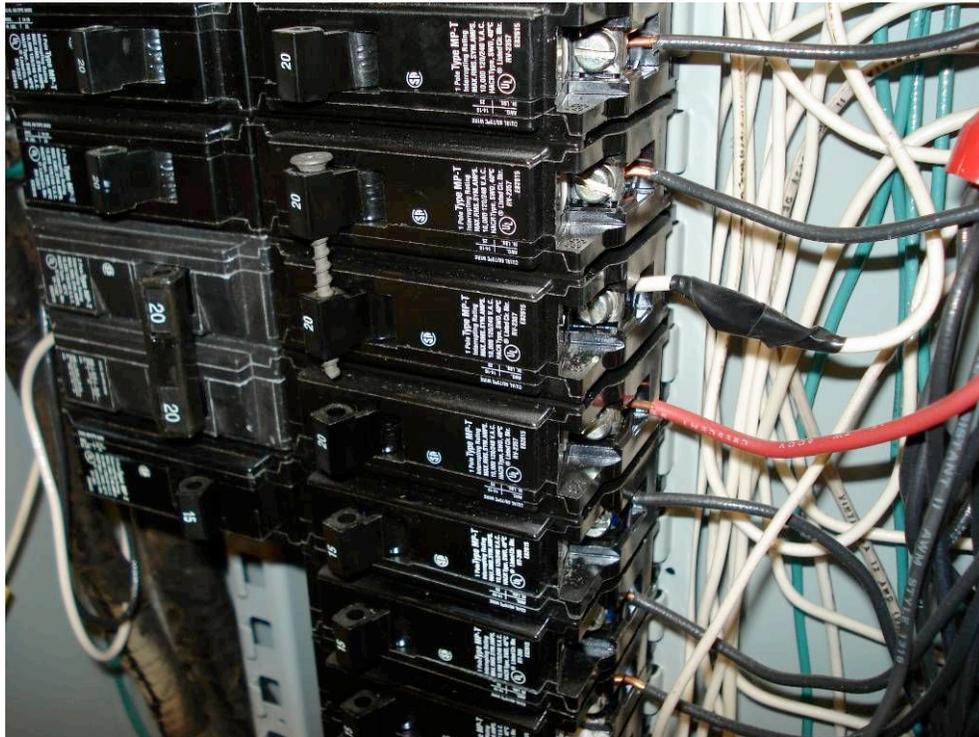
ELECTRICAL PANEL VETS OFFICE W/ SHEET ROCK SCREW

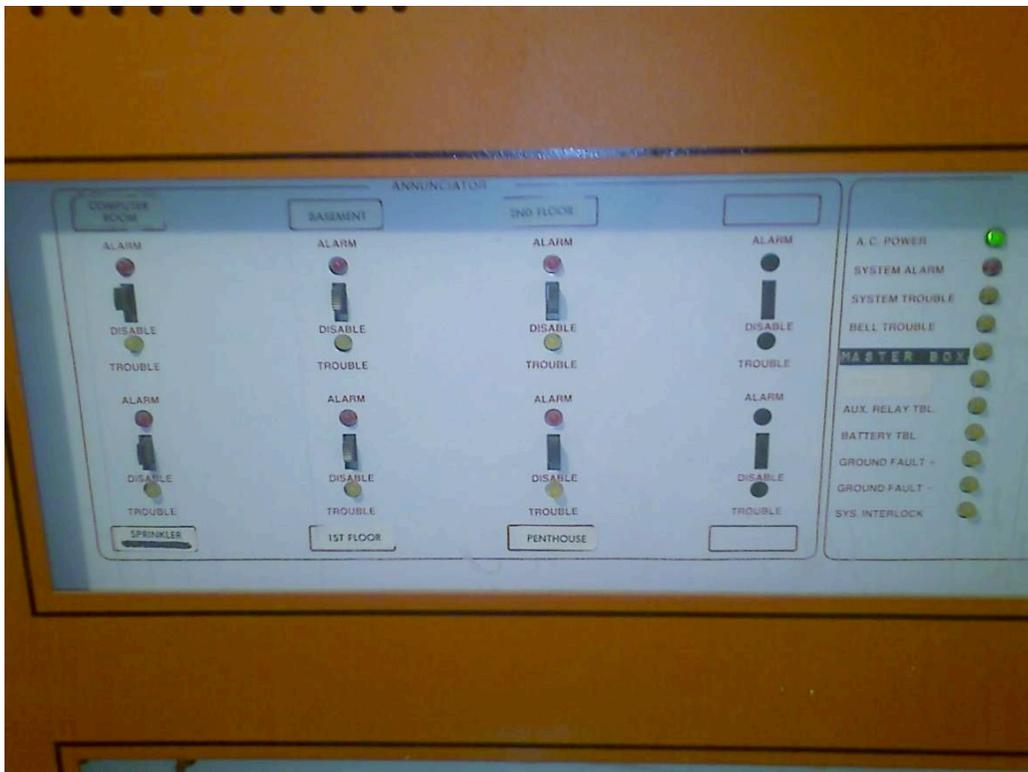
FIRE ALARM PANEL

The fire alarm system is an old 8 zone conventional panel. It appears that six zones are in use. They are labeled, Computer room, Sprinkler, basement, first floor, second floor and penthouse. Under the Sixth Edition of the Mass Building Code, Chapter Nine, Fire Protection, smoke detectors are not required under Use Group A-3 or B. .

The existing fire alarm system does not meet current codes and should be replaced with a new addressable system. An addressable fire alarm system, unlike a convention system, which has a very limited number of zones or addressees, can have hundreds of individual device addresses. In the case of the Needham Town Hall, the existing fire alarm panel only provides for six zones thought-out the building? In the addressable system, each device, smoke detector, heat detector water flow switch, etc is given a unique numeric address that will provide a plain English text of where the alarm is. This allows the fire department to quickly determine where the source of the alarm is located.
