**Temporary Structural
Stabilization Drawings**

PROJECT
Needham Town Hall Wall Bulge Temporary Stabilization

East Wall Bulge Stabilization

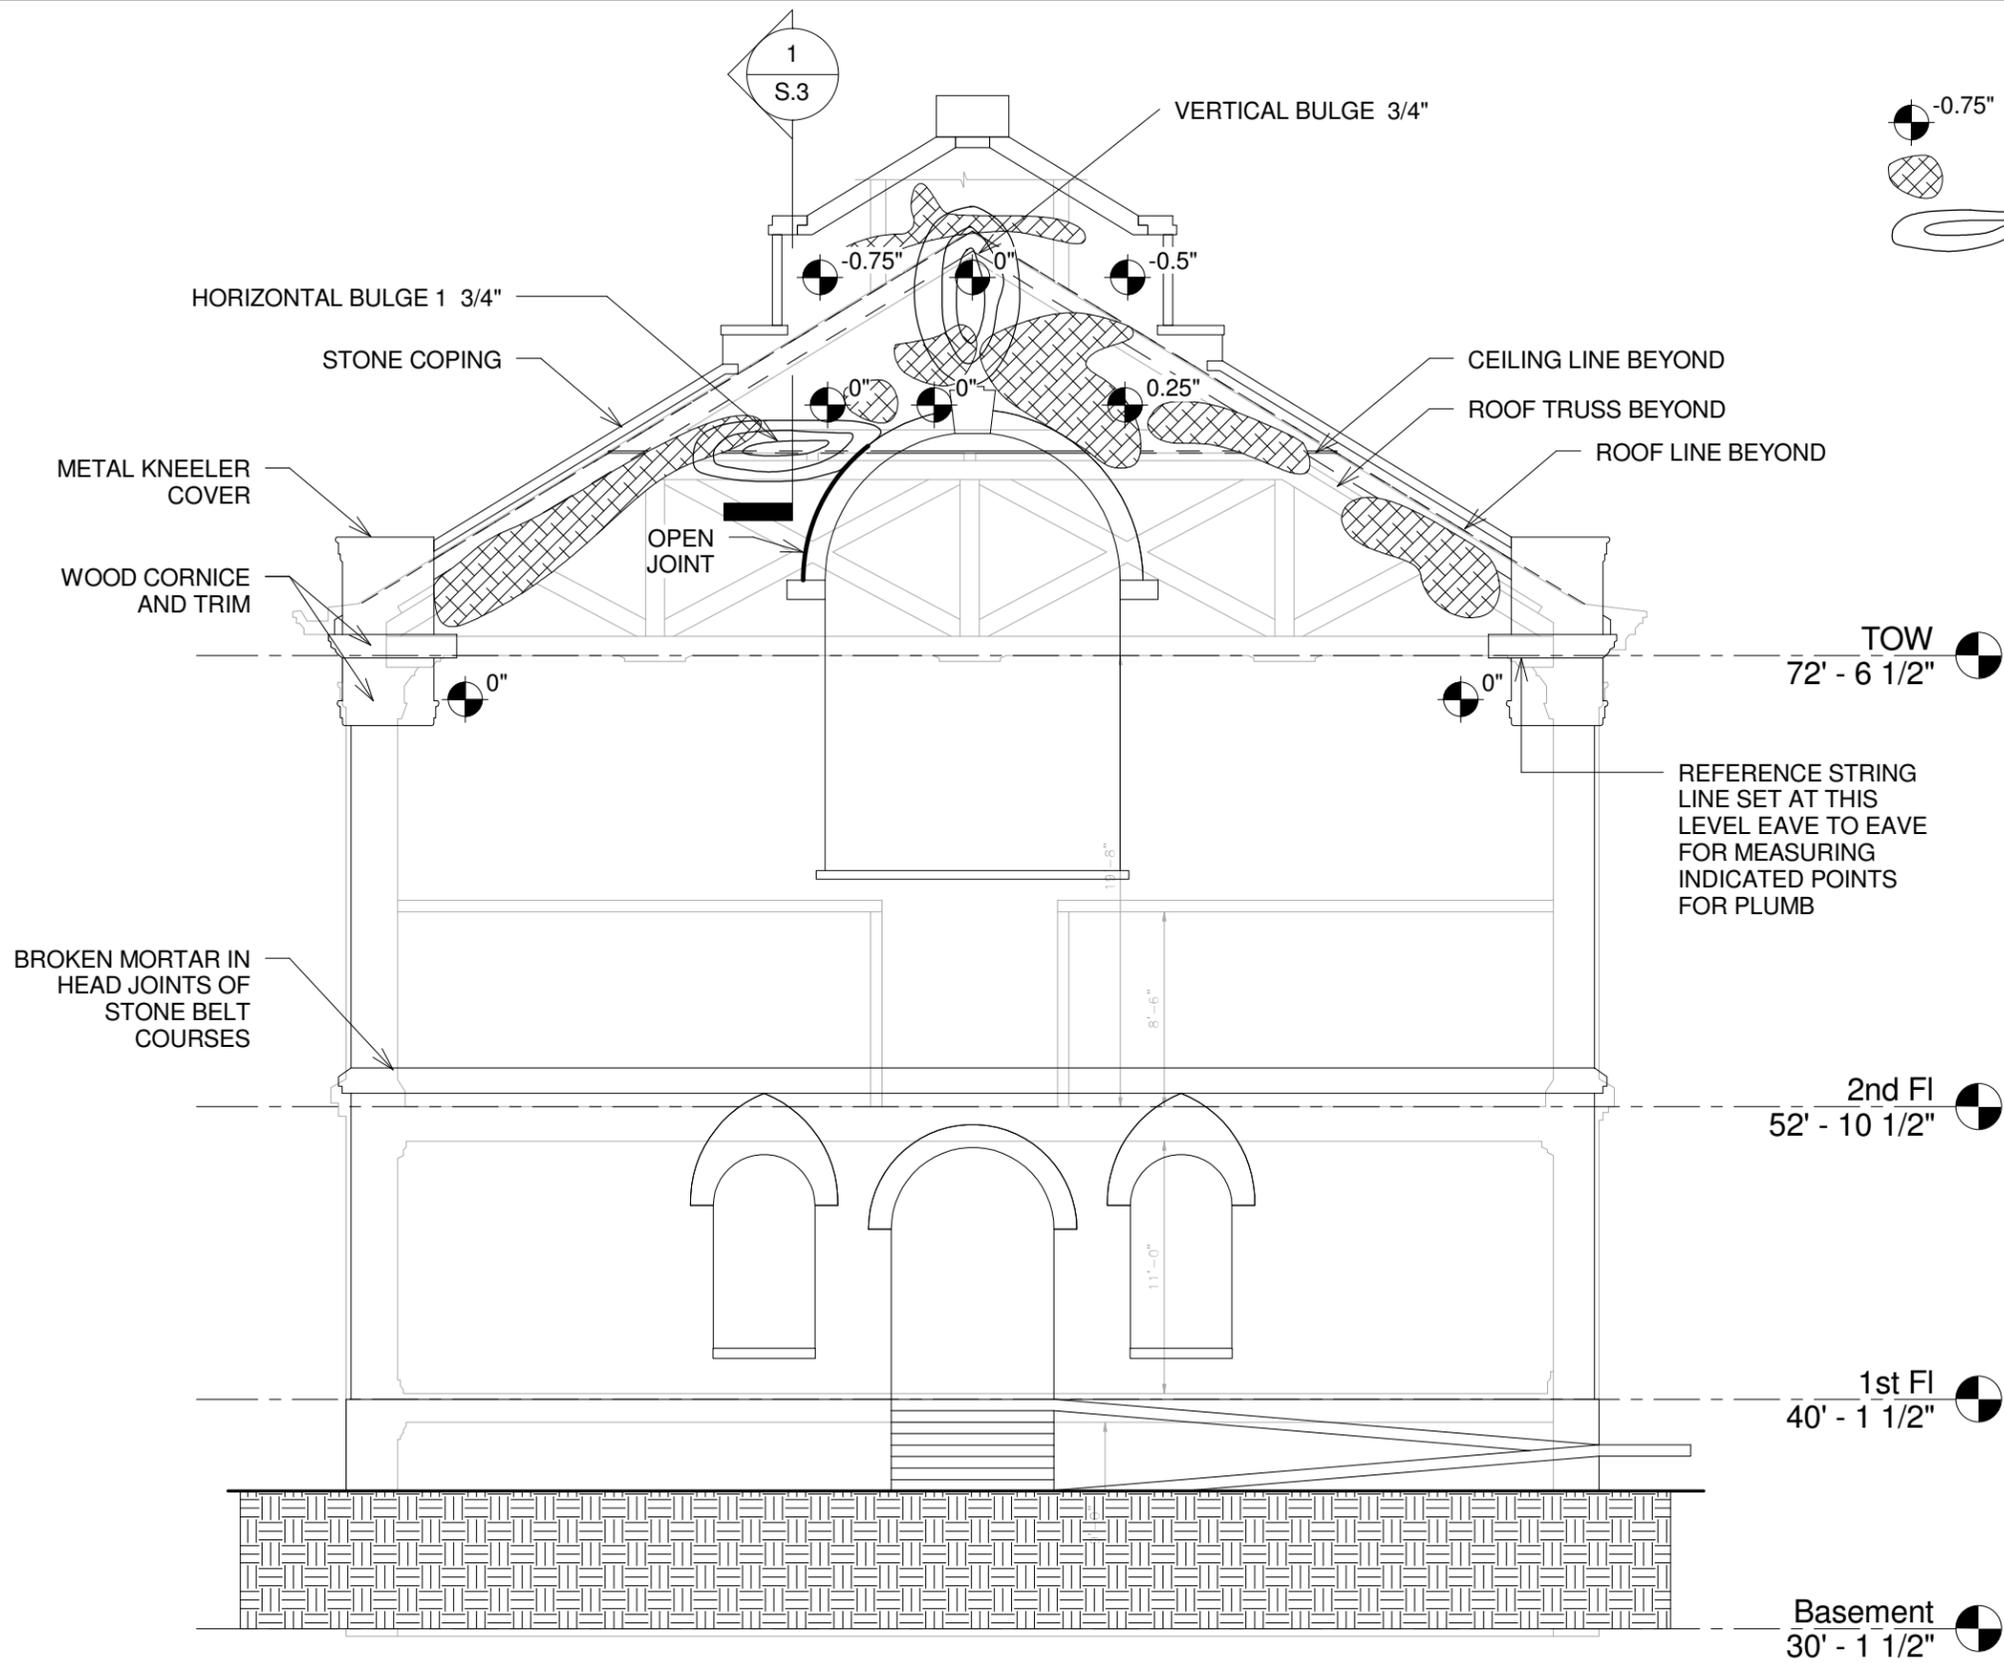
1 East Elevation
1/8" = 1'-0"

- 0.75" DEVIATION FROM VERTICAL PLANE
- CRACKED MASONRY, BROKEN MORTAR
- BULGE CONTOUR

MOST DETERIORATION SEEN IN THESE END WALLS IS NEAR THE ROOF LINE WHERE BRICK CYCLES THROUGH GREATER FREQUENCIES AND RANGES OF TEMPERATURE CHANGES LEADING TO TRAPPED MOISTURE FREEZING WITHIN WALLS DURING WINTERS.

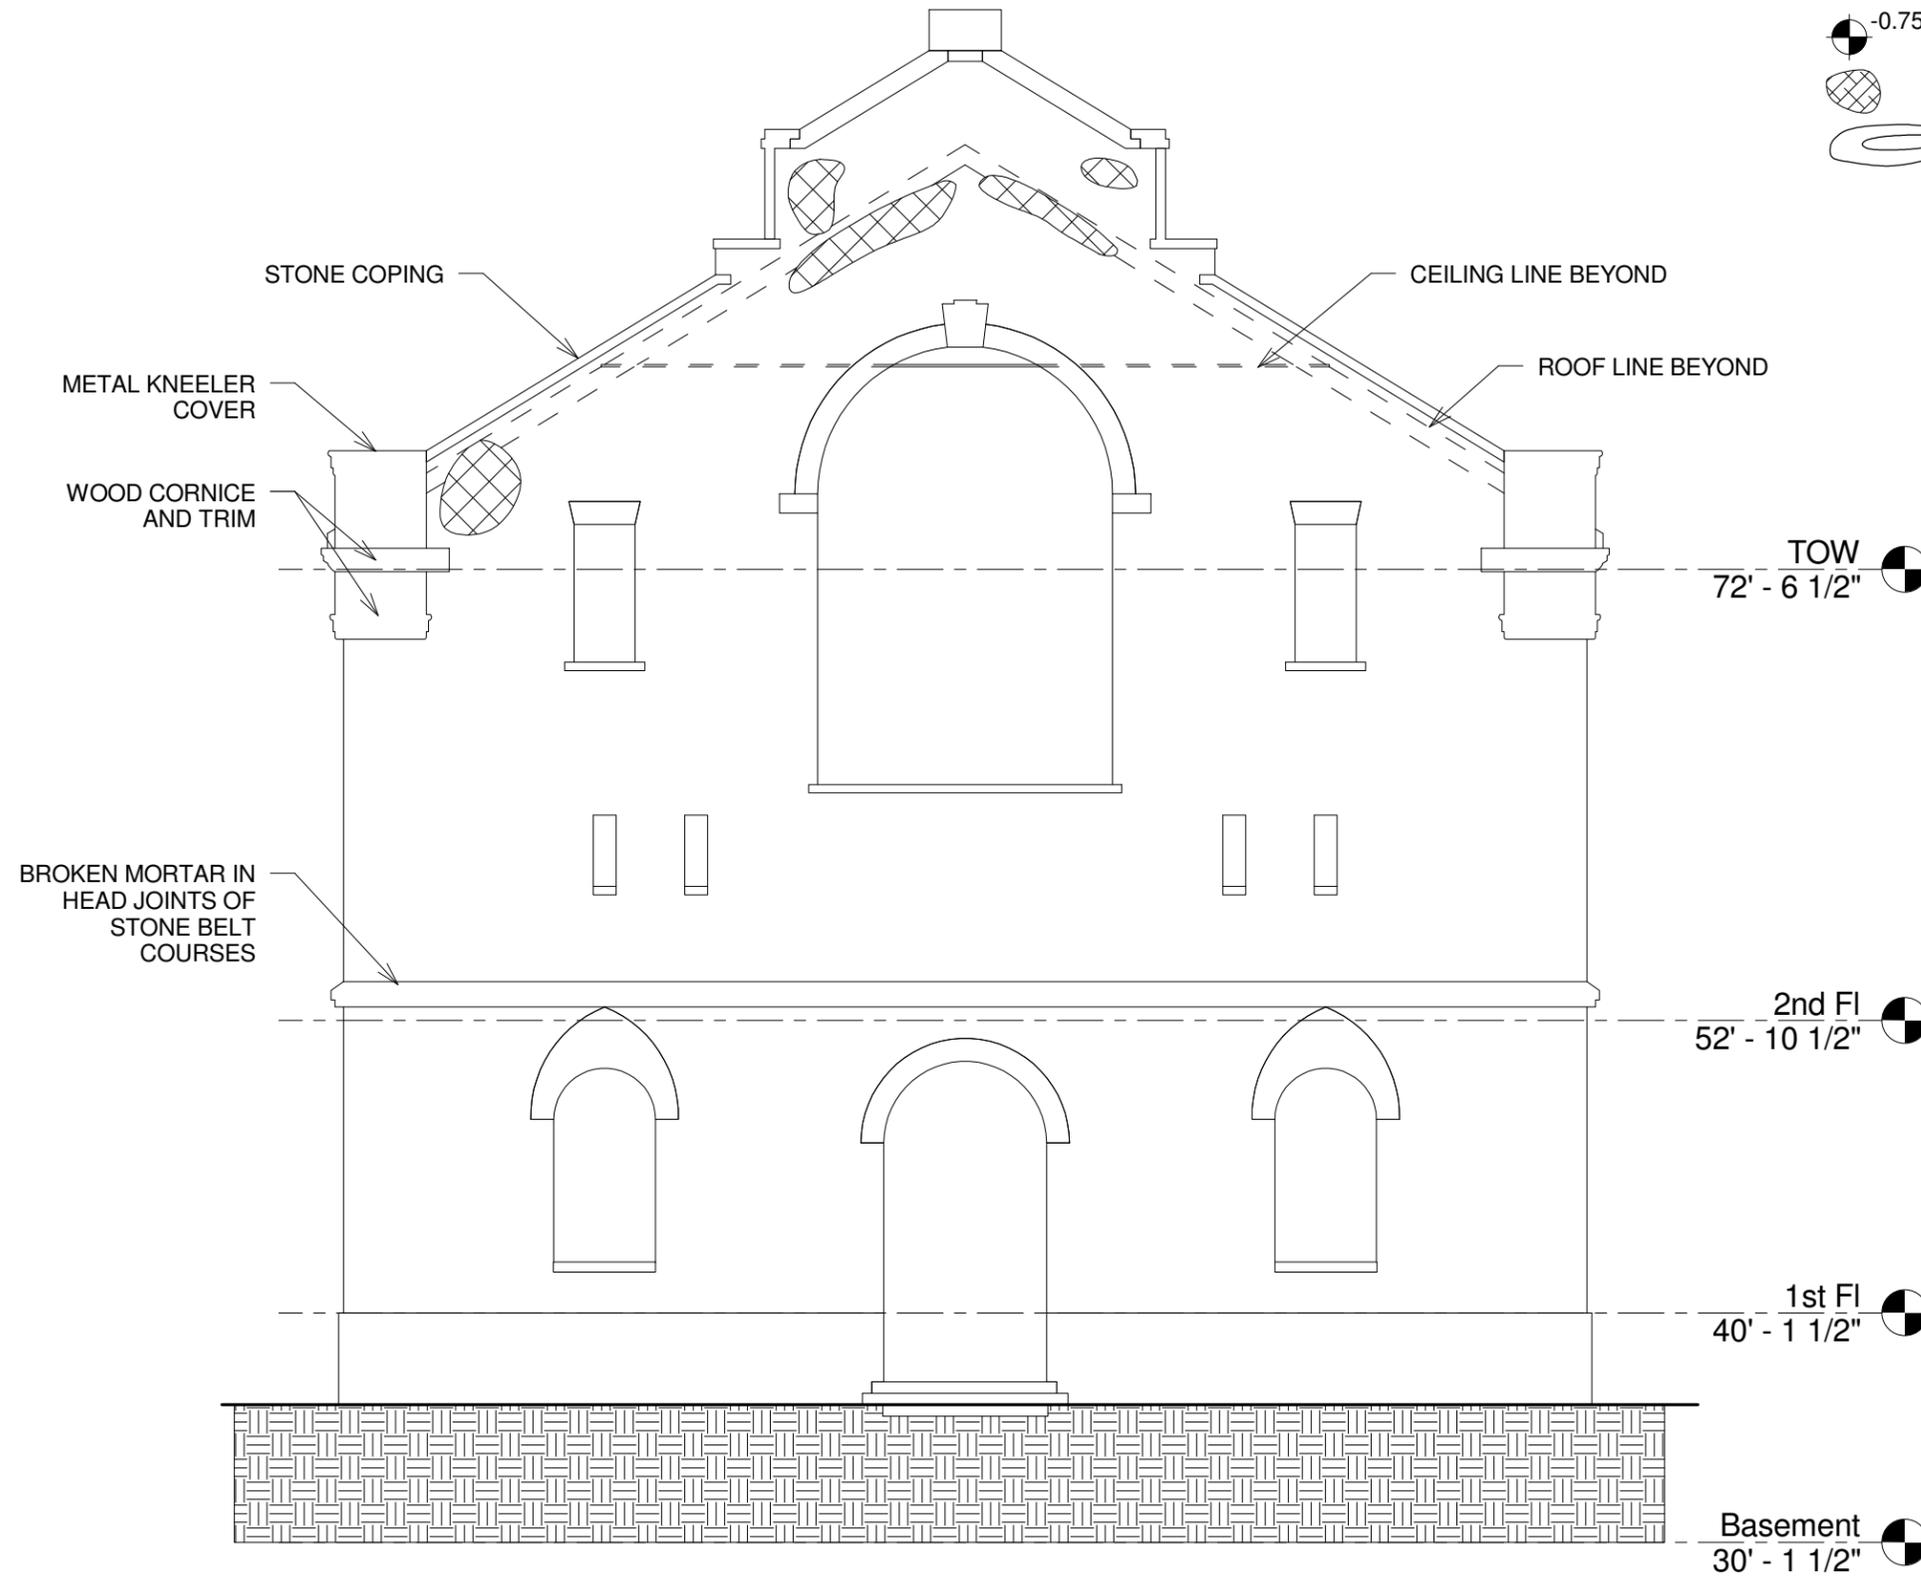
1 West Elevation
1/8" = 1'-0"

- 0.75" DEVIATION FROM VERTICAL PLANE
- CRACKED MASONRY, BROKEN MORTAR
- BULGE CONTOUR

MOST DETERIORATION SEEN IN THESE END WALLS IS NEAR THE ROOF LINE WHERE BRICK CYCLES THROUGH GREATER FREQUENCIES AND RANGES OF TEMPERATURE CHANGES LEADING TO TRAPPED MOISTURE FREEZING WITHIN WALLS DURING WINTERS.

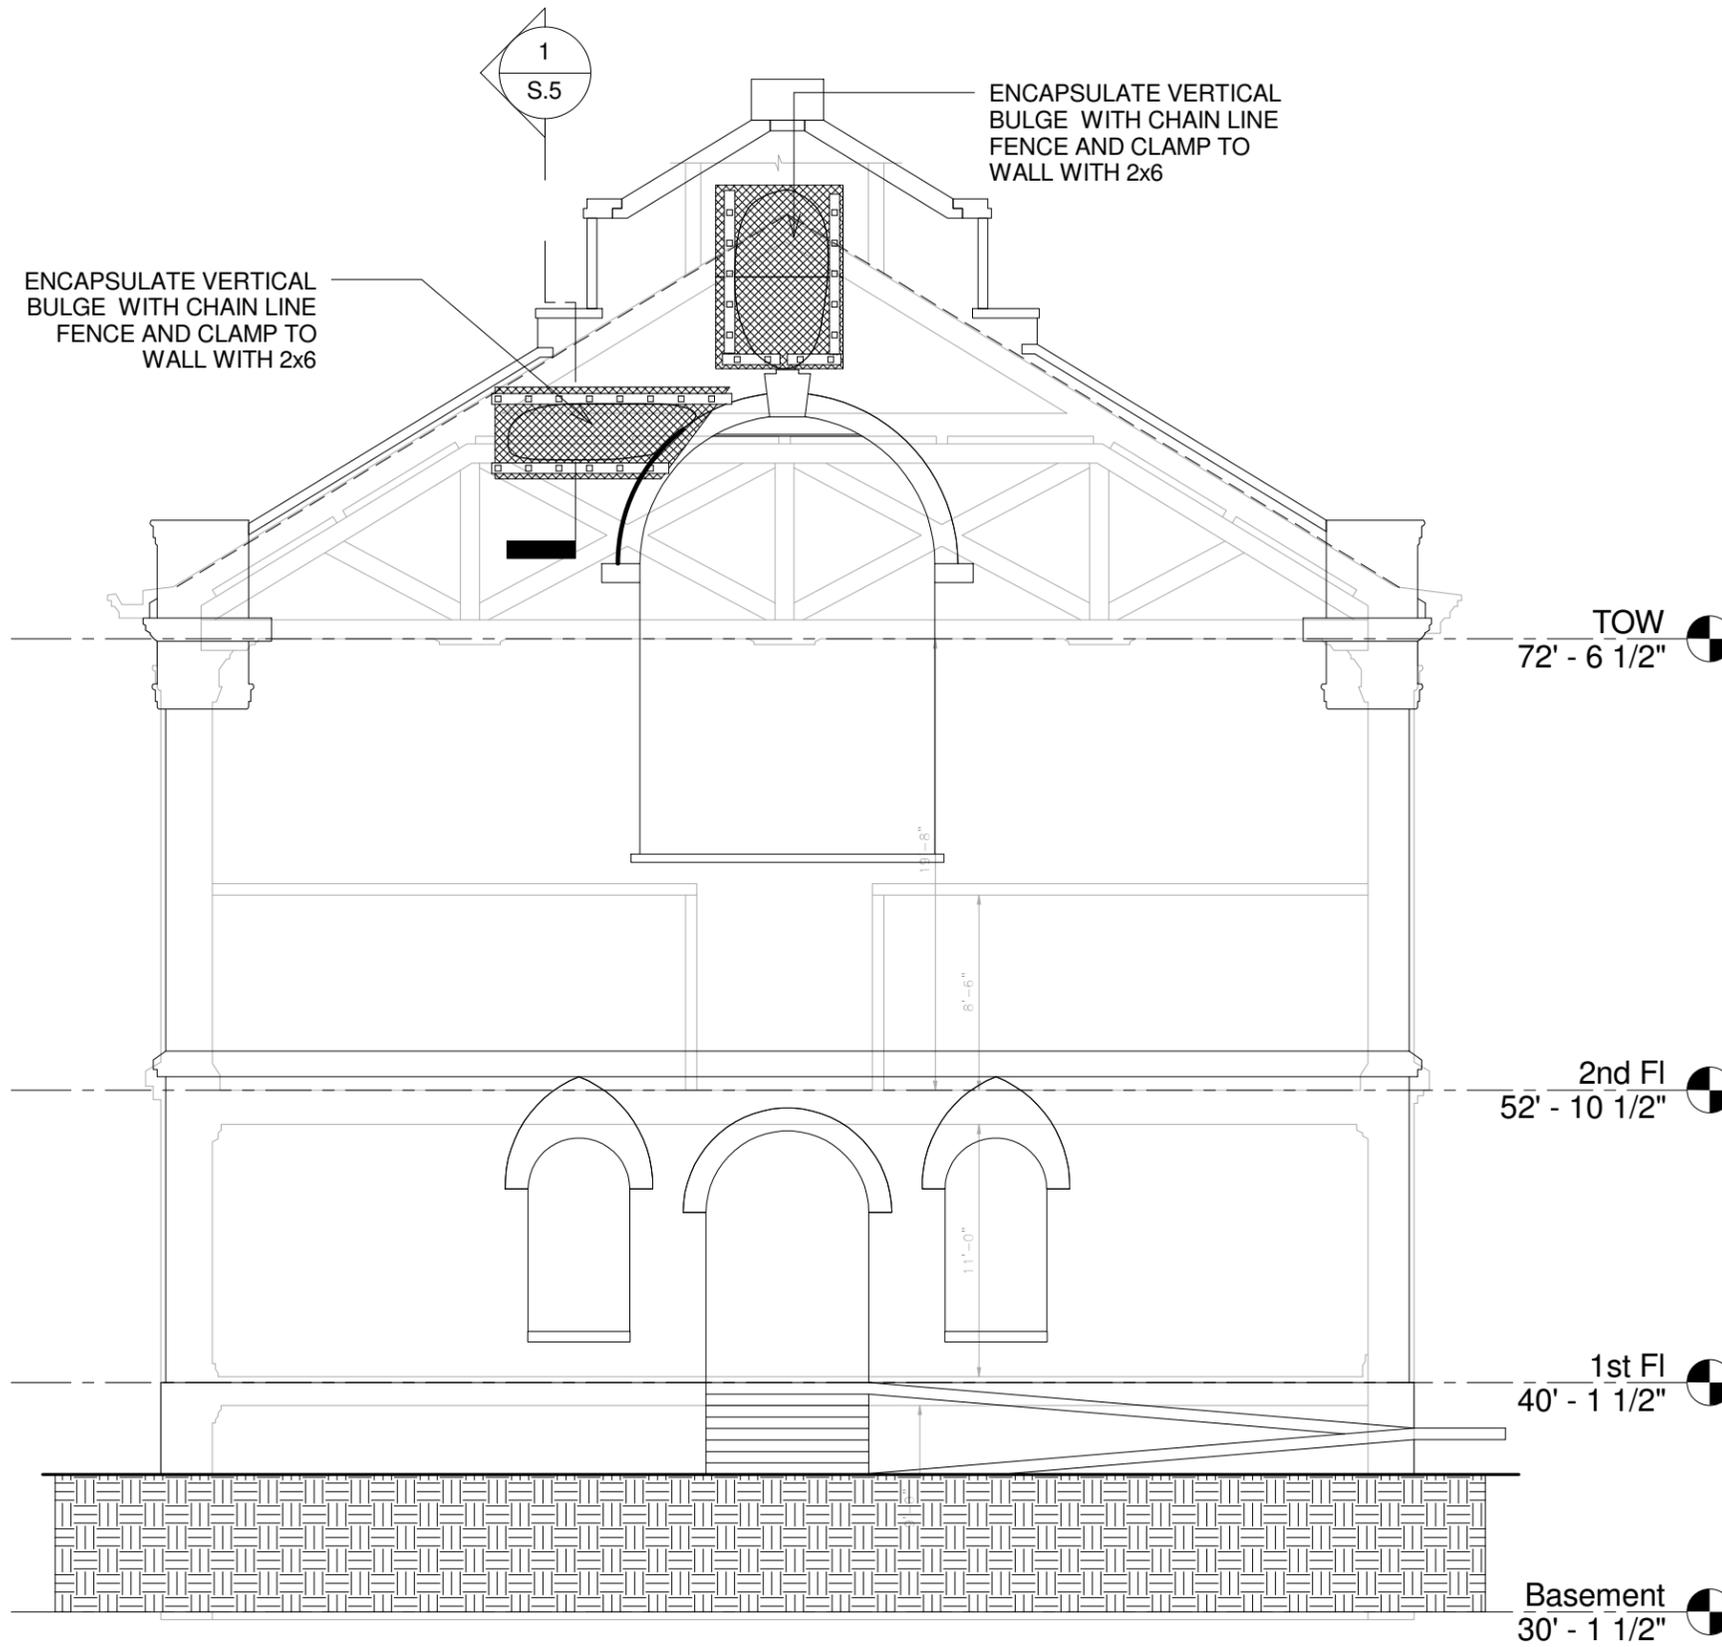
1 East Elevation Temporary Brace
1/8" = 1'-0"

Work shown on these drawings is intended to provide information for stabilization of two bulges in the east wall. Sheets S1 and S3 illustrate existing conditions. Sheets S4 and S5 illustrate stabilization repairs.

Lumber: Spruce-Pine-Fir select structural grade pressure treated with ACQ

Bolts: Type A304 or A316 stainless steel threaded rod with stainless steel nuts.

Plate Washers: A36 steel either hot dipped galvanized or two coats of epoxy based paint

Epoxy Adhesive: Simpson EpoxyTie EFT anchoring adhesive or approved equal.

Fence mesh: Two inch diamond, 9 gauge mesh with a vinyl coating. Color as accepted by town

Restrict access to area below work area to protect public while carrying out repairs.
