PHOTOS

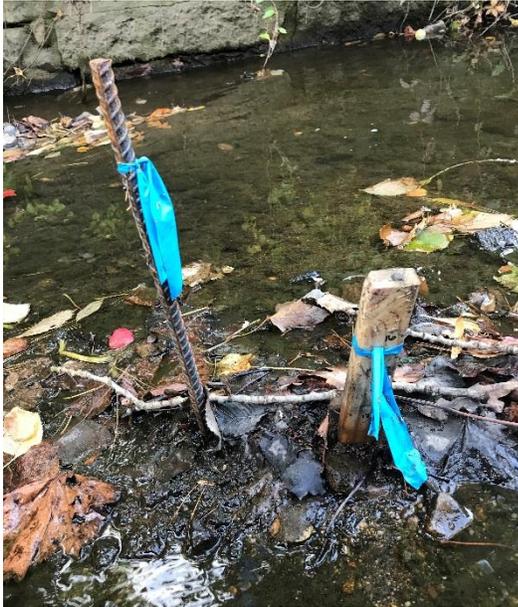
Station 1 (Petrini Apt.): Before Drawdown (10/7/2019)

Station 1 (Petrini Apartments) – Turbidity, velocity, and sediment depth readings taken on Monday, prior to drawdown and Wednesday after initiation of drawdown. Photo on left pre-drawdown and photo on the right during drawdown. Note: 0.13 inches of rain had fallen this week prior to monitoring on 10/9/19.

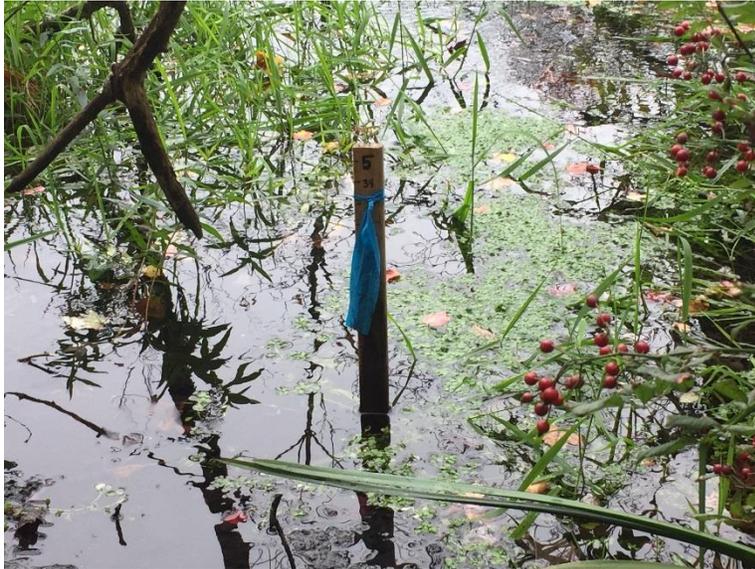
Station 5.5 (Whalen Property) – First turbidity, velocity, and sediment depth readings taken at all substations on Whalen property, after initiation of drawdown. Stations similar to previous events. (10/9/2019)

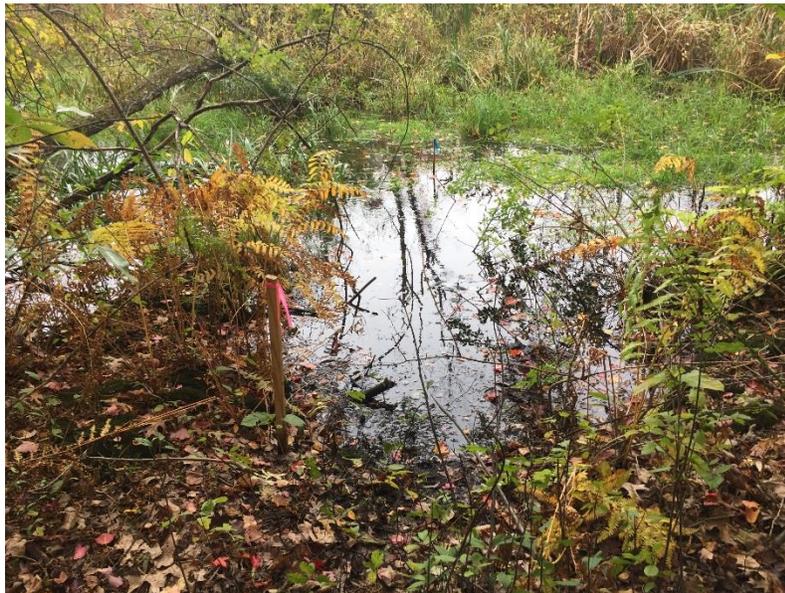
Station 5.4 (Whalen Property) – Edge of Bank shown. First turbidity, velocity, and sediment depth readings taken at all substations on Whalen property, after initiation of drawdown. Stations similar to previous events. (10/9/2019)

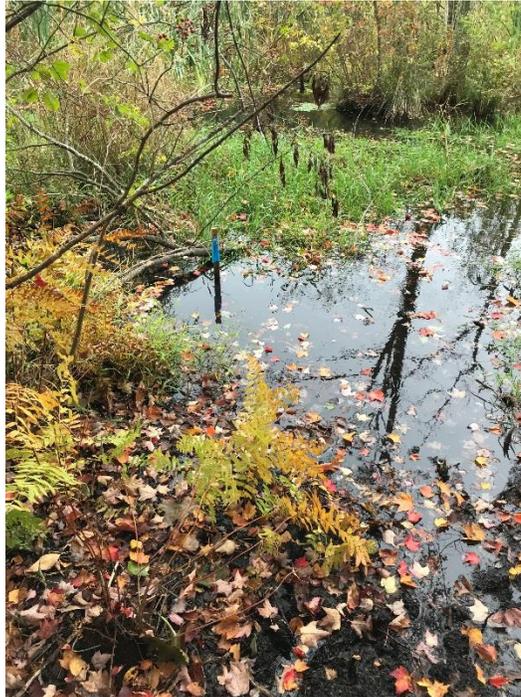
Station 5.2 (Whalen Property) – Edge of Bank shown. First turbidity, velocity, and sediment depth readings taken at all substations on Whalen property, after initiation of drawdown. Water level lower than previous events. (10/9/2019)

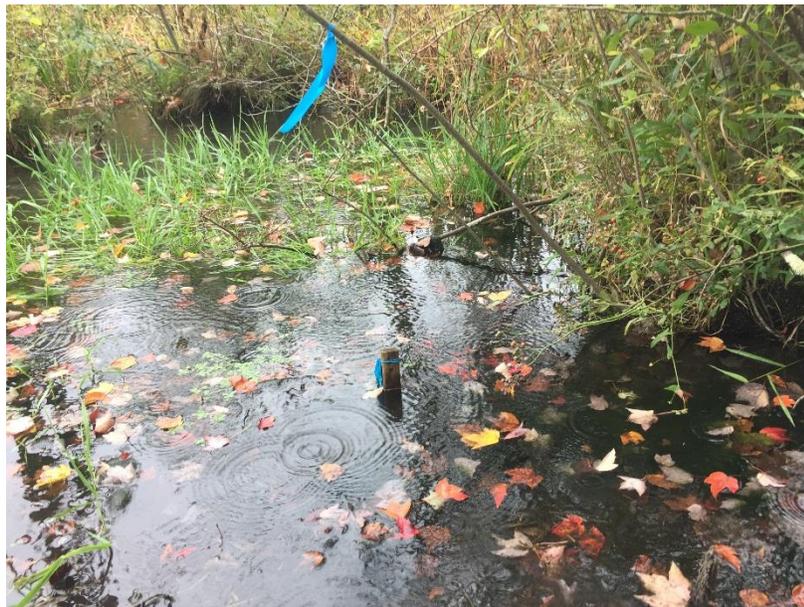
Station 5.1 (Whalen Property) – First turbidity, velocity, and sediment depth readings taken at all substations on Whalen property, after initiation of drawdown. Water level lower than previous events. (10/9/2019)

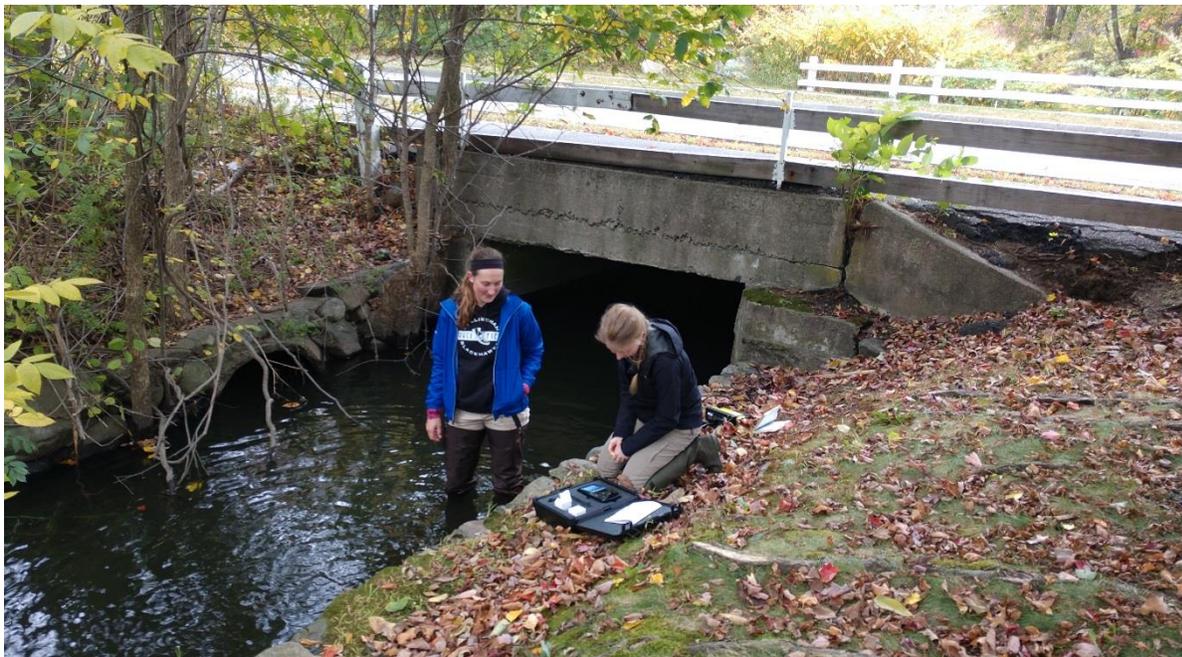
Turbidity and flow readings being collected on Friday (10/11)

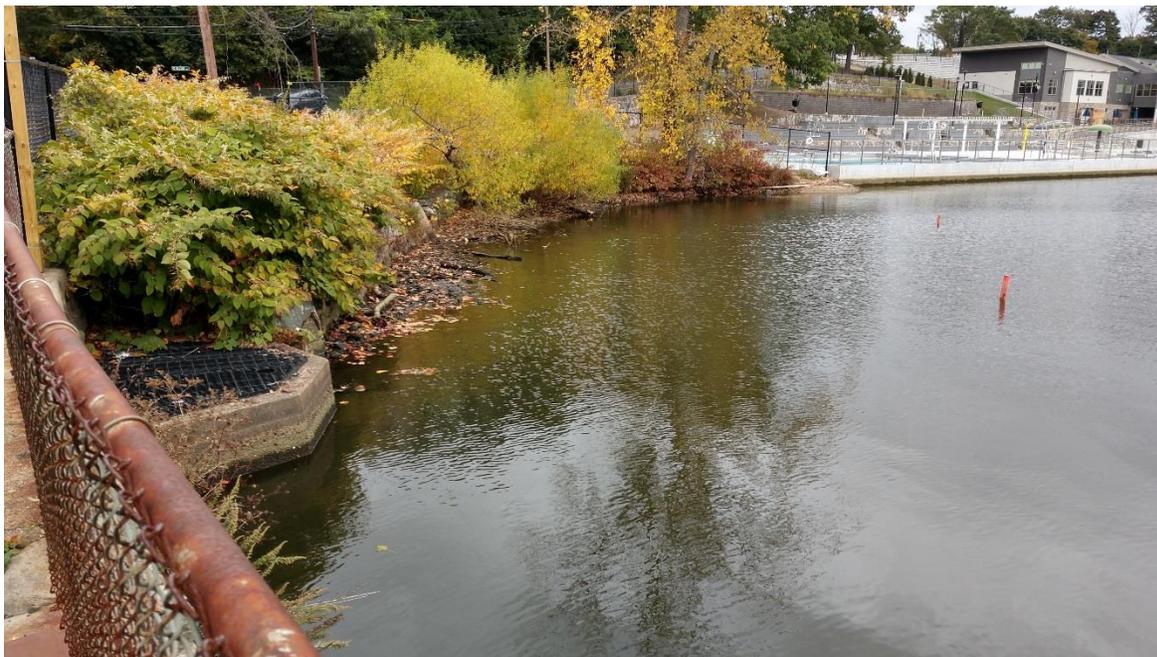
Lake near outlet two days after drawdown initiated.
