## WEEKLY SUMMARY REPORT

| Client: | Needham DPW | Dates: | 11/25/2019 to 11/27/2019 |
| Contract: | Rosemary Lake Dredging | | |

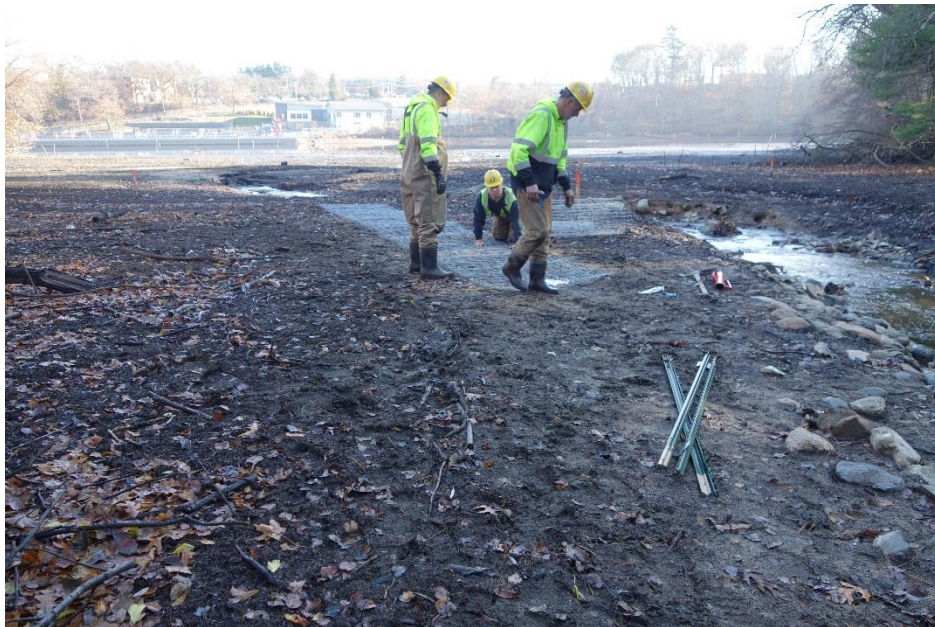
**Fish nets installed across Lake inlets**

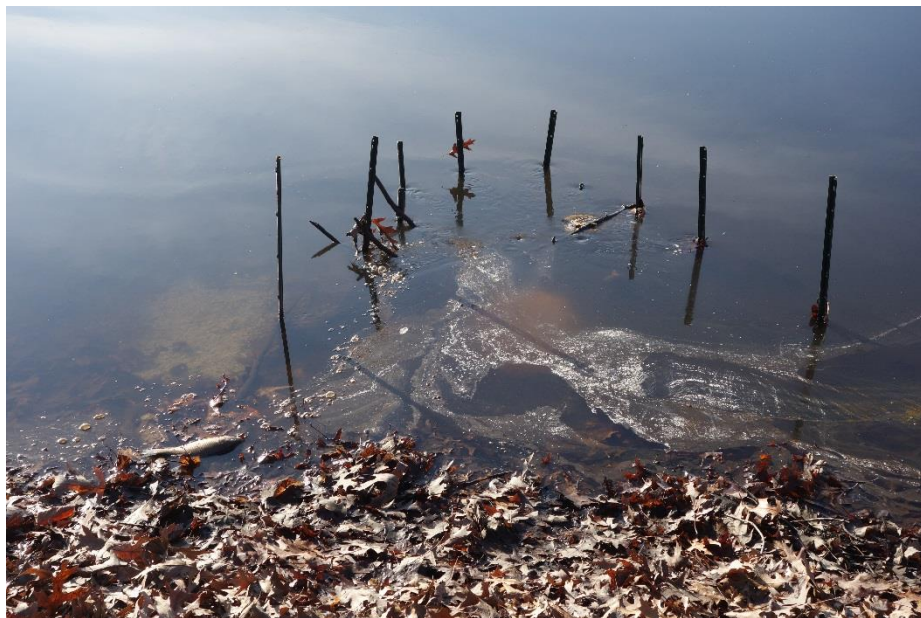
**Stone Check Dam at outfall**

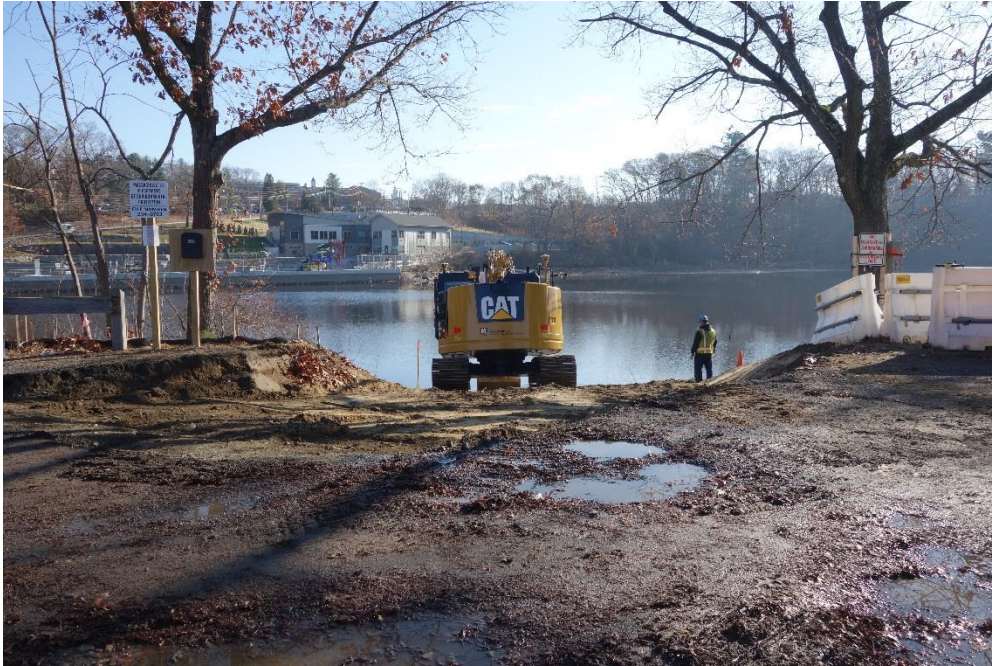
Tuesday (11/26/2019)

**Beginning stages of access ramp construction at Staging Area**

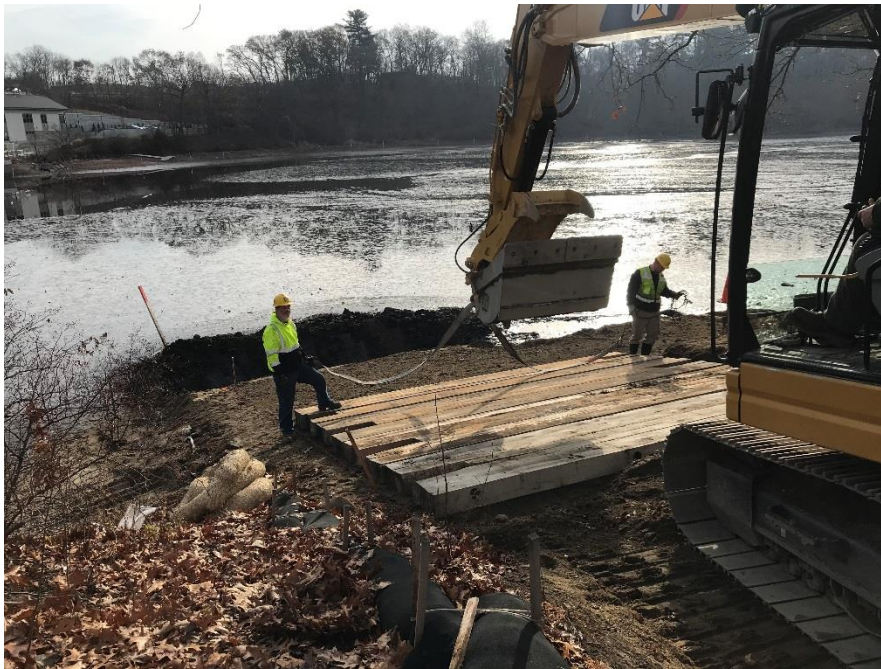
Wednesday (11/27/2019)

**Access ramp construction at Staging Area**

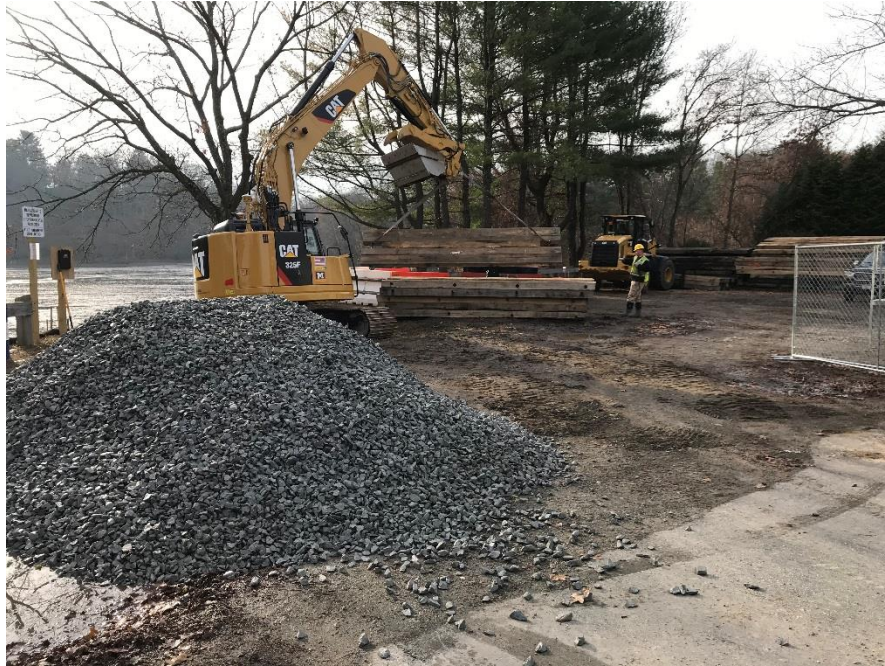
**Gravel for Staging Area**

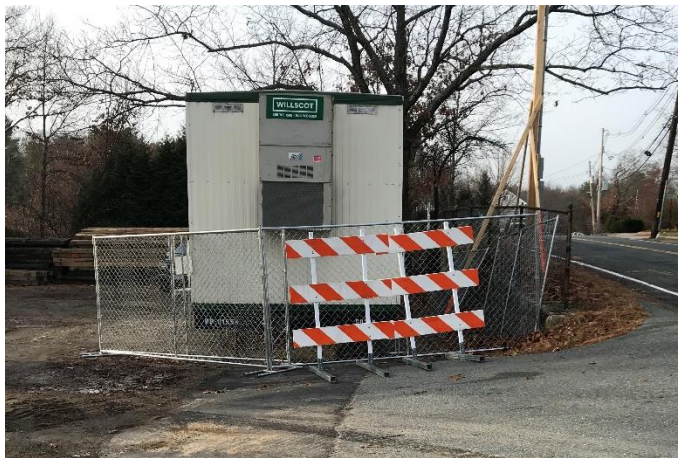
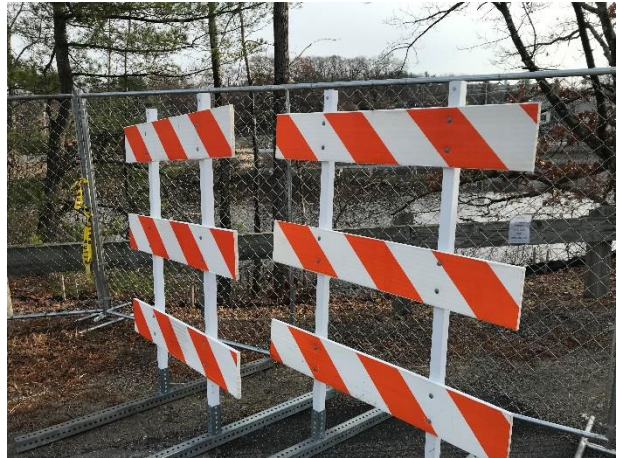
**Gate at Staging Area installed**

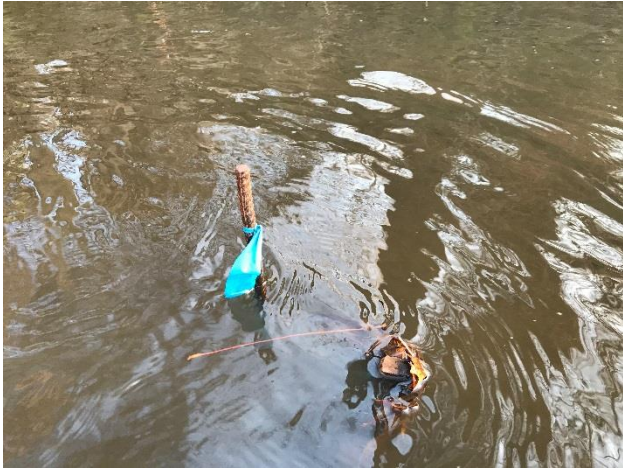
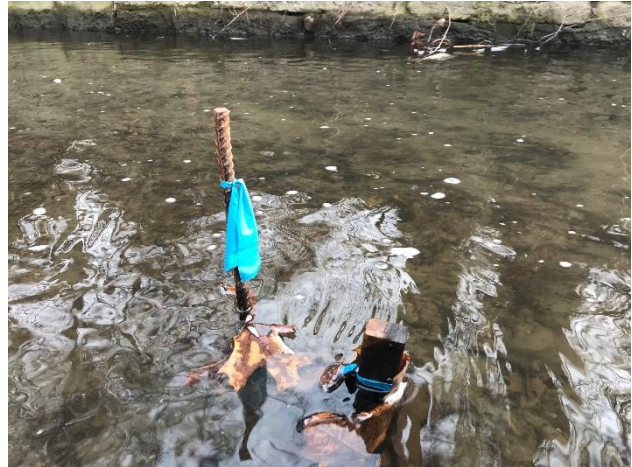
**Station 1 (Petrini Property) – Turbidity and sediment depth readings taken on Monday and Wednesday. Turbidity continues to decrease at Station 1.**

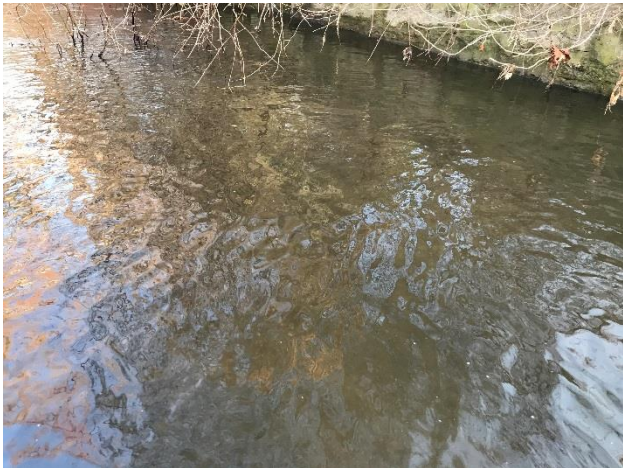
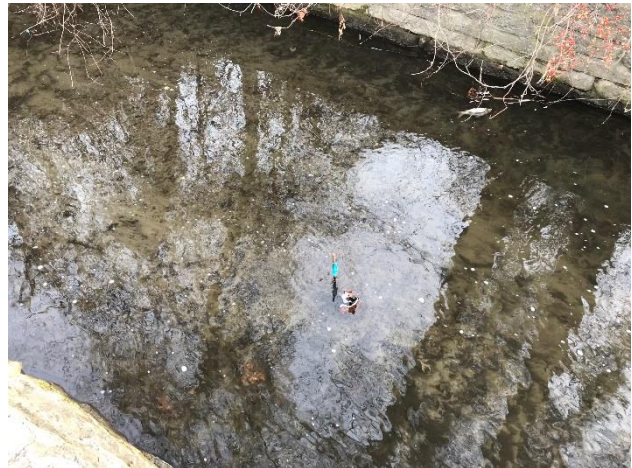
**Station 1 (Petrini Property) – Turbidity and sediment depth readings taken on Monday and Wednesday. Turbidity continues to decrease at Station 1.**

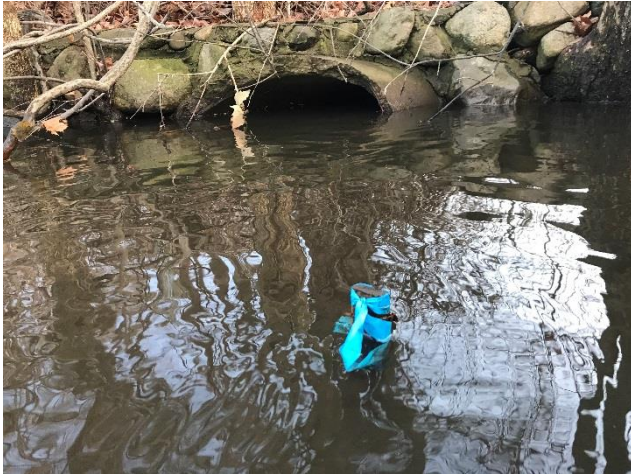
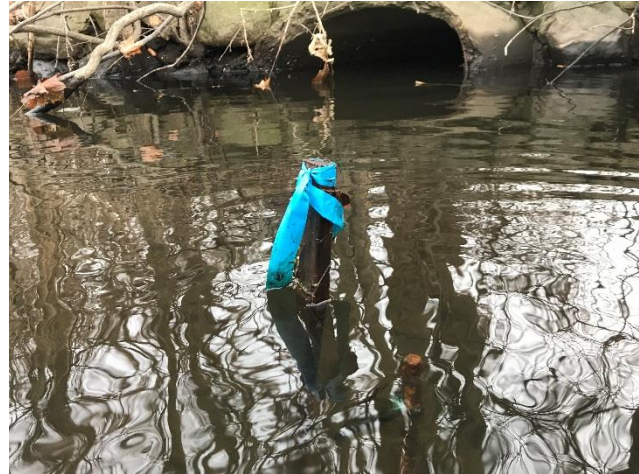
**Station 2 (West Street) – Turbidity and sediment depth readings taken on Tuesday and Friday. Water level higher than previous week.**

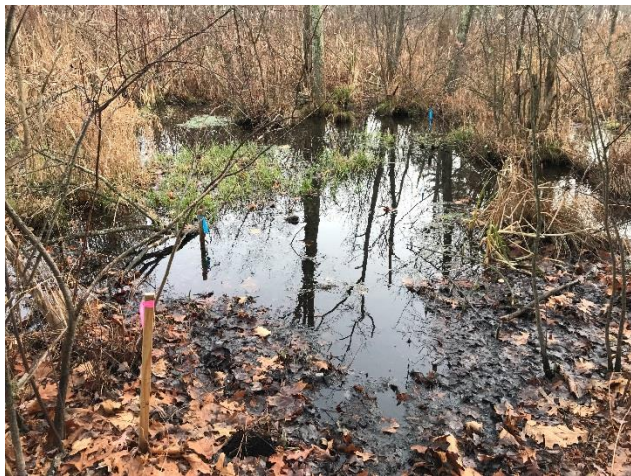
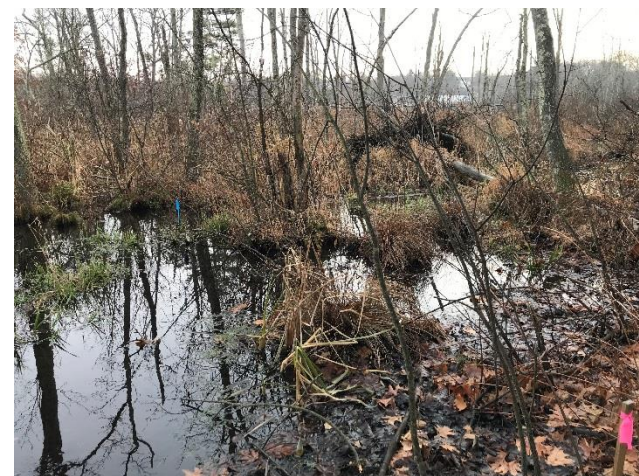
Station 5.1 and 5.2 (11/27/2019)

**Station 5.1 and 5.2 – Edge of Bank shown. Turbidity and sediment depth readings taken on Friday.**

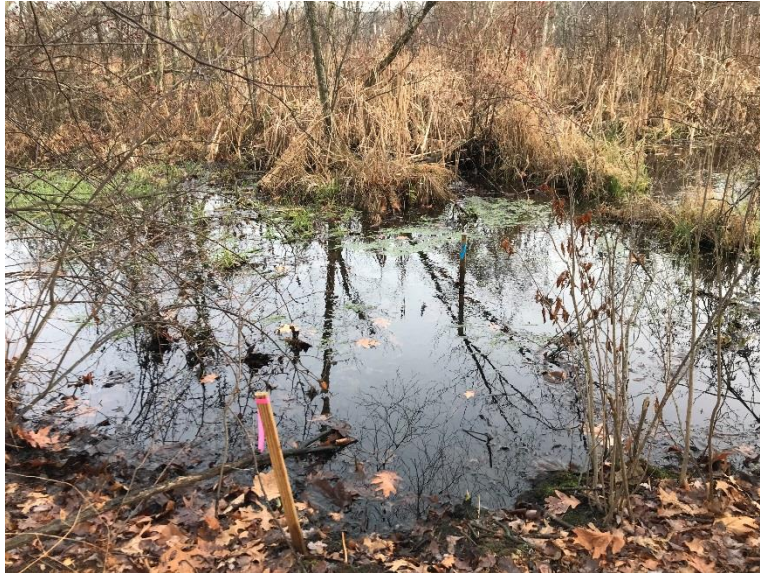
Station 5.3(11/27/2019)

**Station 5.3 – Edge of Bank shown. Turbidity and sediment depth readings taken on Friday.**

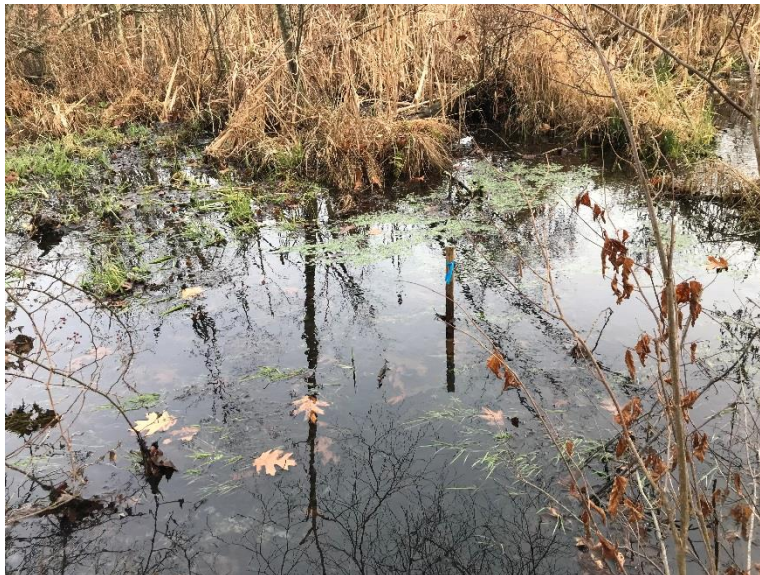
Station 5.3 (11/27/2019)

**Station 5.3 – Turbidity and sediment depth readings taken on Friday.**

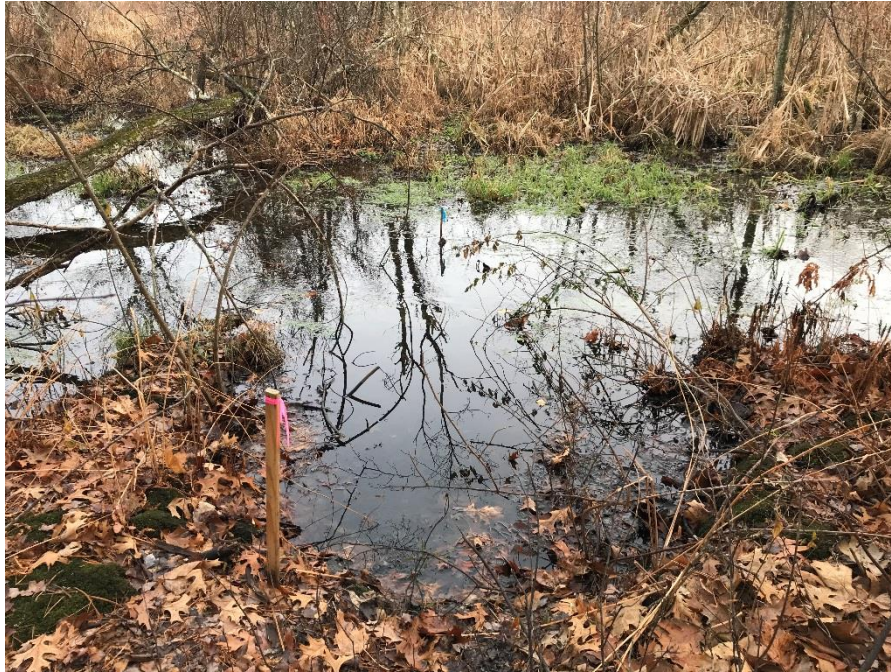
Station 5.4 (11/27/2019)

**Station 5.4– Edge of Bank shown. Turbidity and sediment depth readings taken on Friday.**

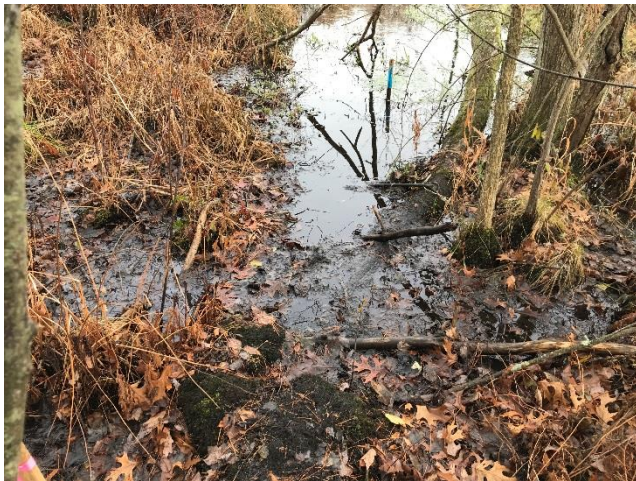
Station 5.5 (11/27/2019)

**Station 5.5 – Edge of Bank shown. Turbidity and sediment depth readings taken on Friday.**
