PHOTOS

Needham DPW
Rosemary Lake Dredging

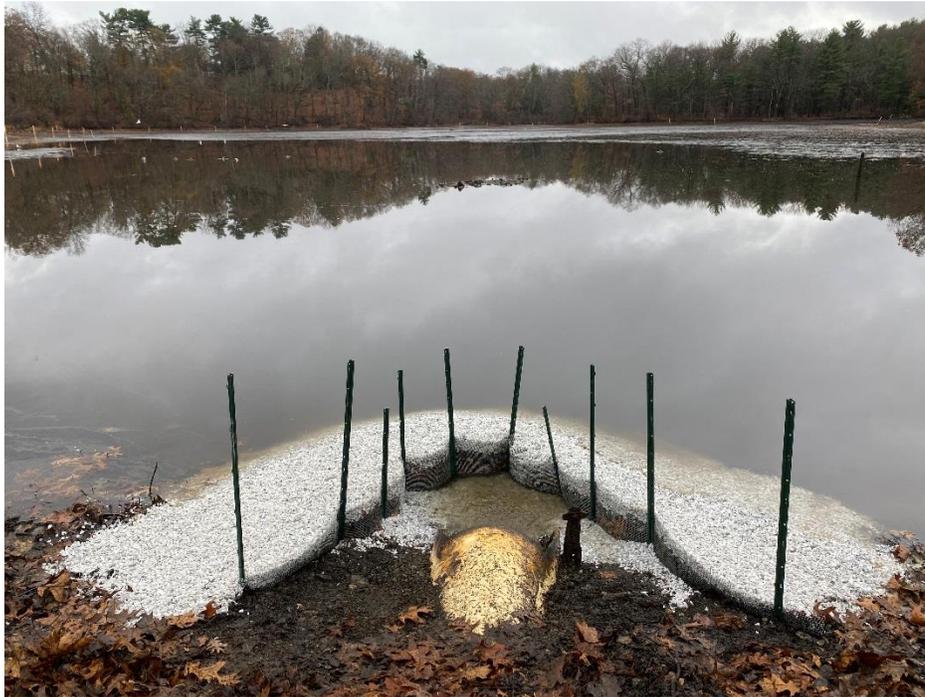
Stone Check Dam installed at outfall

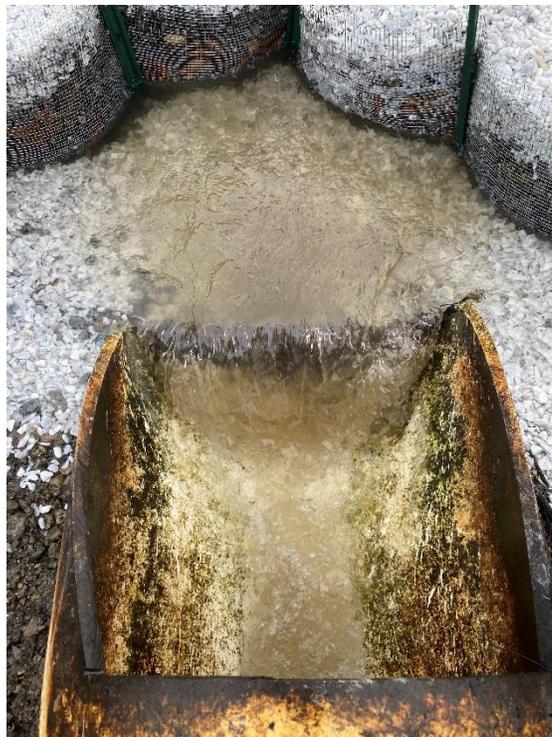
Stone Check Dam installed at outfall

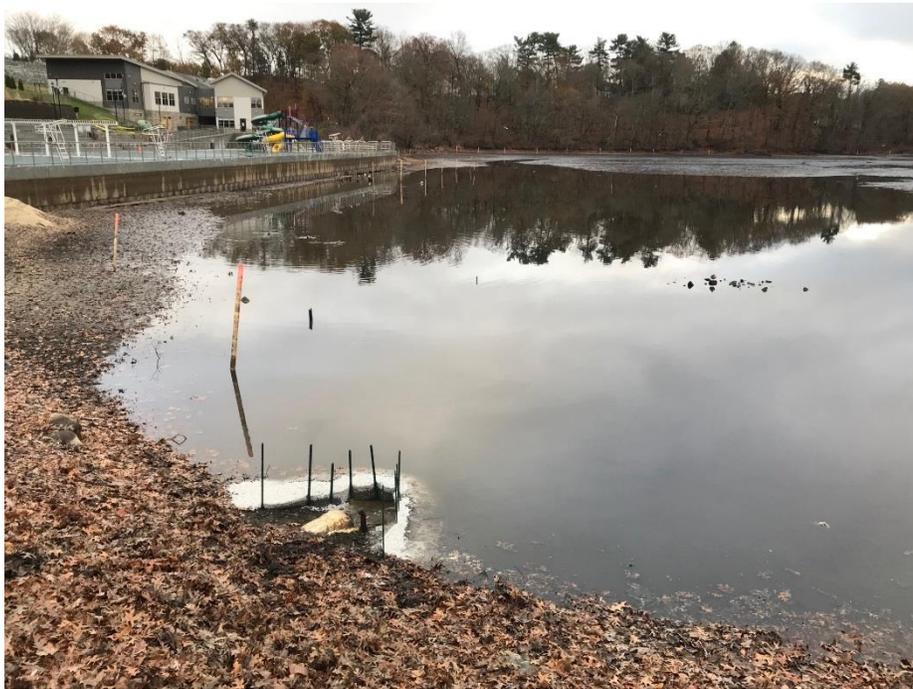
Stone Check Dam installed at outfall

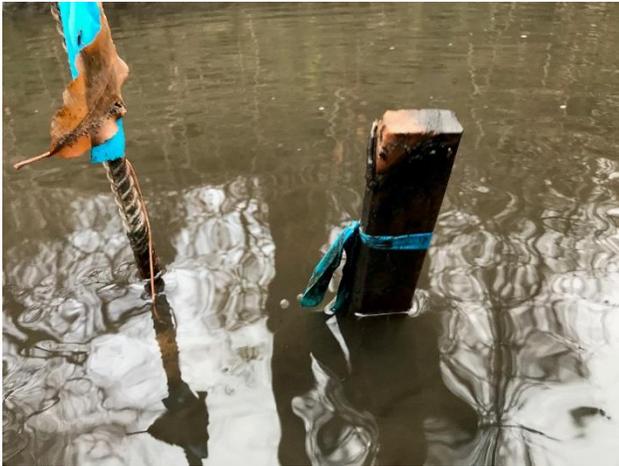
Tuesday (11/19/2019)

Station 1 (Petrini Property) – Turbidity and sediment depth readings taken on Tuesday and Friday. Turbidity decreased at Station 1.

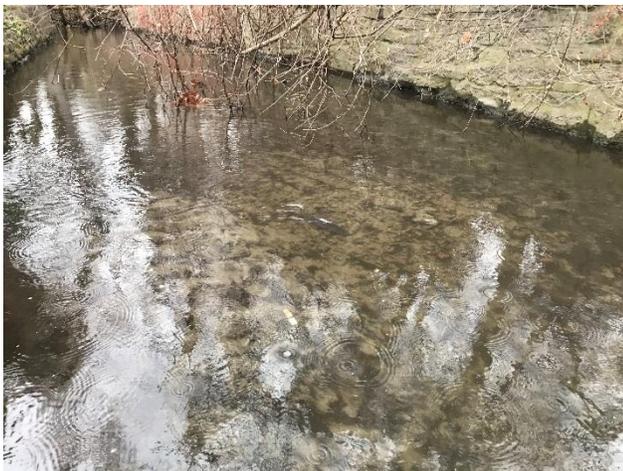
Fish near stake past foot bridge. (11/22/2019)

Station 1 (Petrini Property) – Turbidity and sediment depth readings taken on Tuesday and Friday. Fish noted at Station 1 (near outfall and past foot bridge).

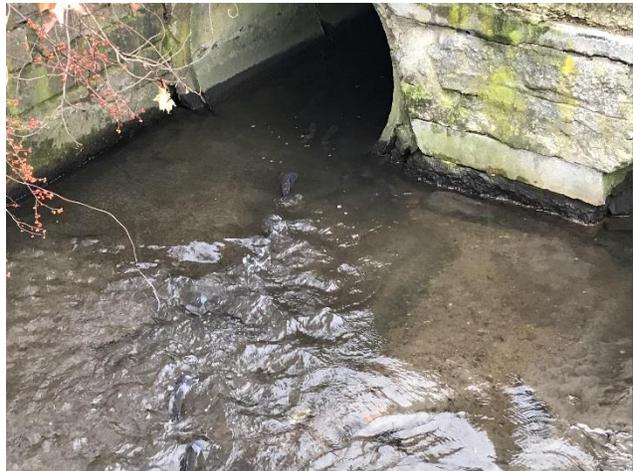
Fish swimming upstream toward Lake. (11/22/2019)

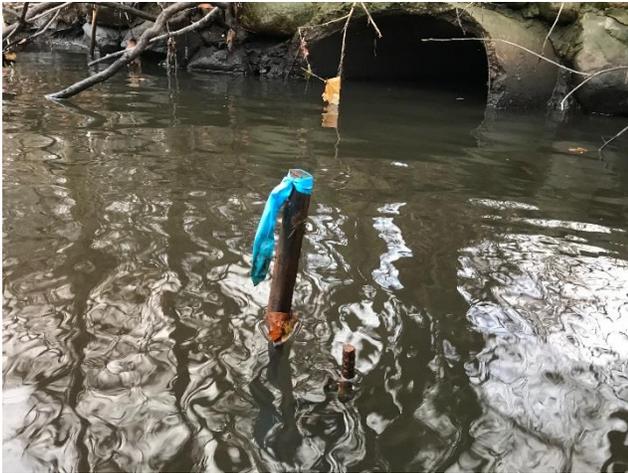
Tuesday (11/19/2019)

Station 2 (West Street) – Turbidity and sediment depth readings taken on Tuesday and Friday. Turbidity decreased at Station 2.

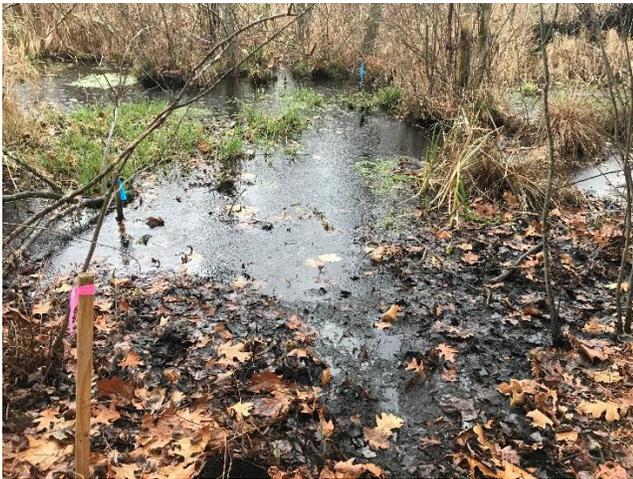
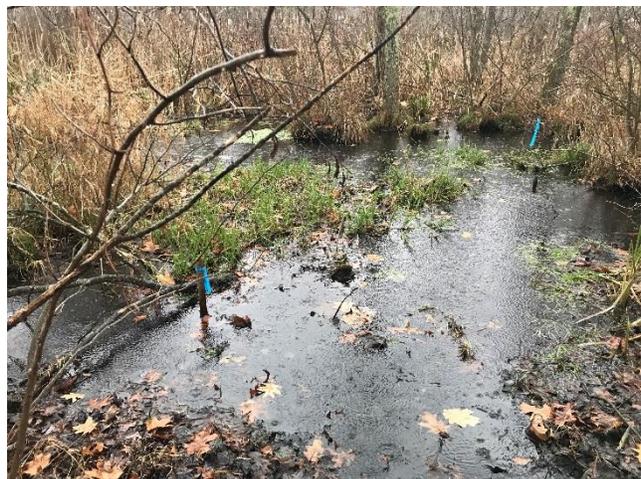
Station 5.1 and 5.2 (11/22/2019)

Station 5.1 and 5.2 – Edge of Bank shown. Turbidity and sediment depth readings taken on Friday. Rain occurred during monitoring.

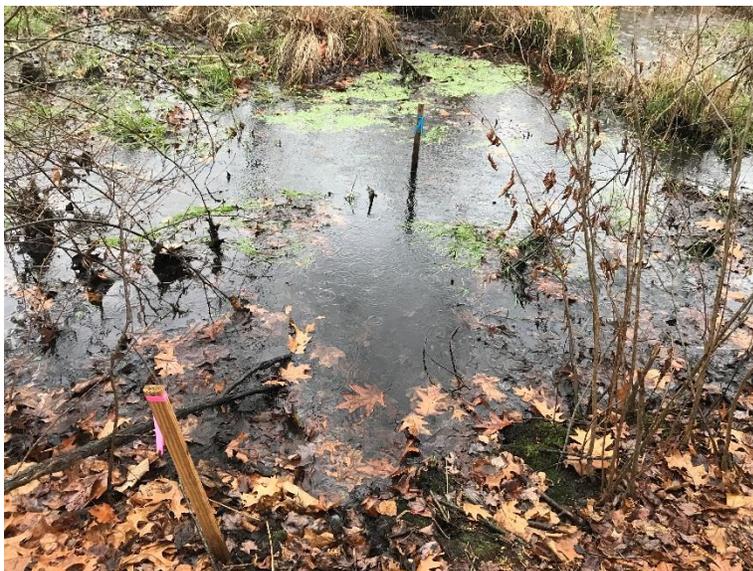
Station 5.3(11/22/2019)

Station 5.3 – Edge of Bank shown. Turbidity and sediment depth readings taken on Friday. Rain occurred during monitoring.

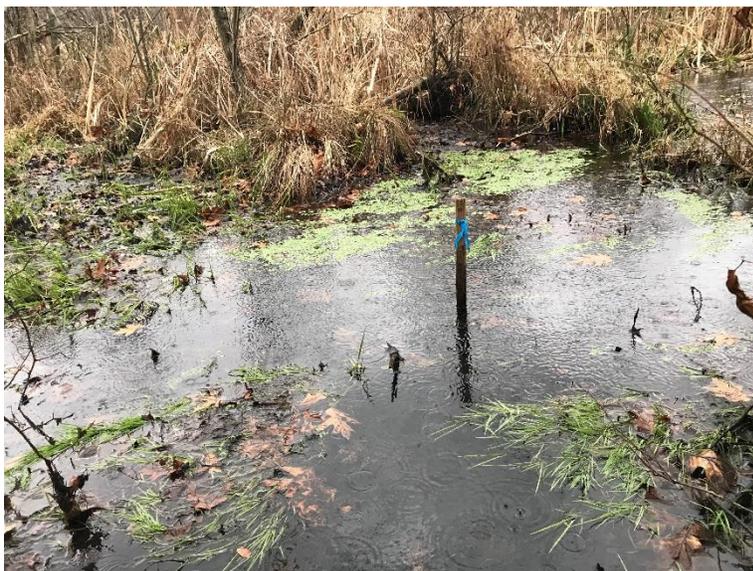
Station 5.3 (11/22/2019)

Station 5.3 – Turbidity and sediment depth readings taken on Friday. Rain occurred during monitoring.

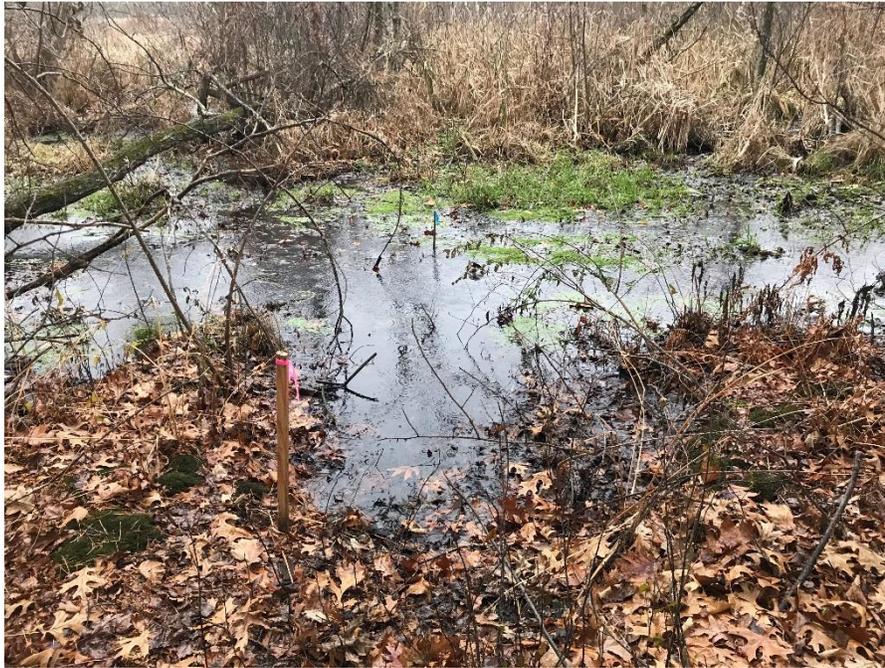
Station 5.4 (11/22/2019)

Station 5.4– Edge of Bank shown. Turbidity and sediment depth readings taken on Friday. Rain occurred during monitoring.

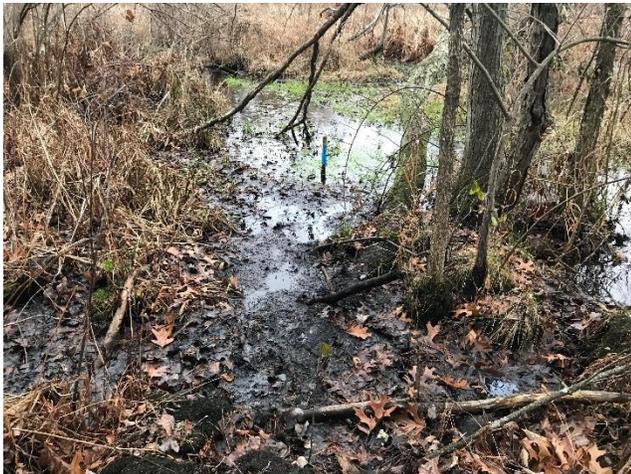
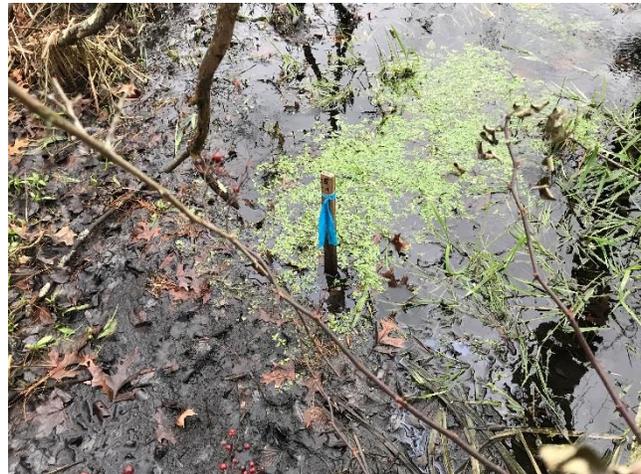
Station 5.5 (11/22/2019)

Station 5.5 – Edge of Bank shown. Turbidity and sediment depth readings taken on Friday. Rain occurred during monitoring.
