**Temporary Structural
Stabilization Drawings**

PROJECT
Needham Town Hall Wall Bulge Temporary Stabilization

East Wall Bulge Stabilization

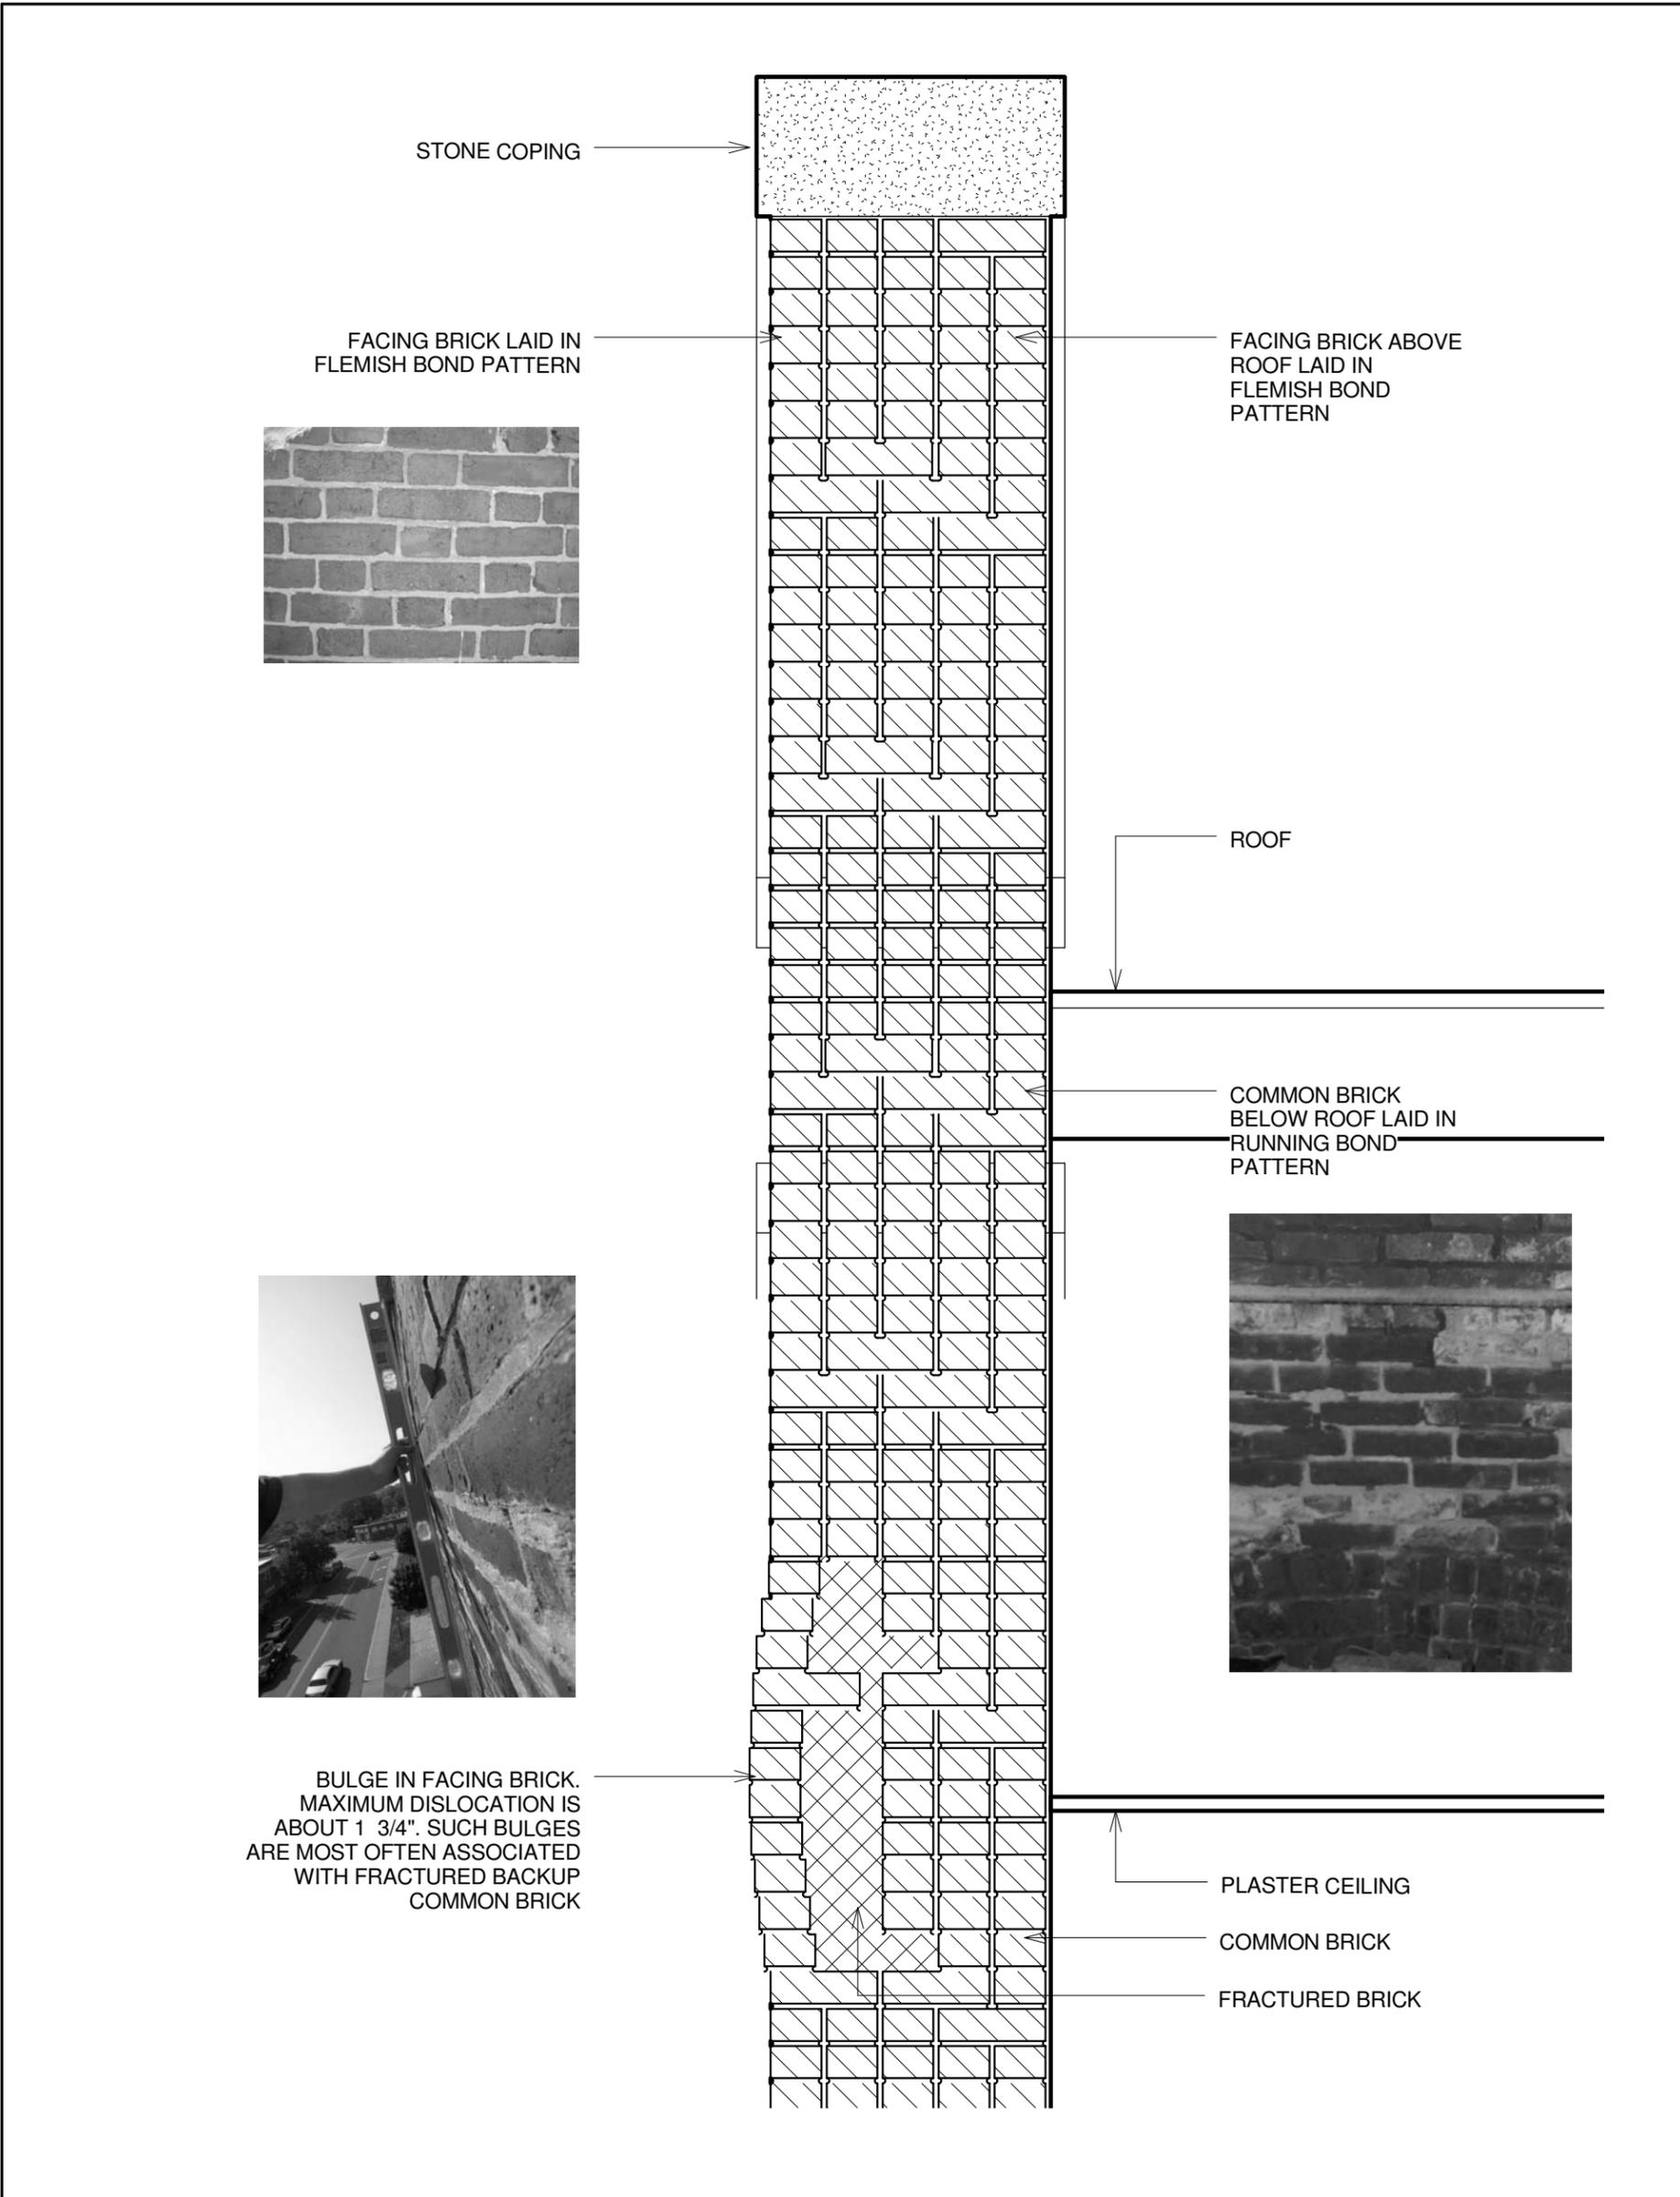
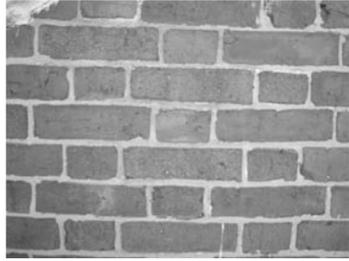
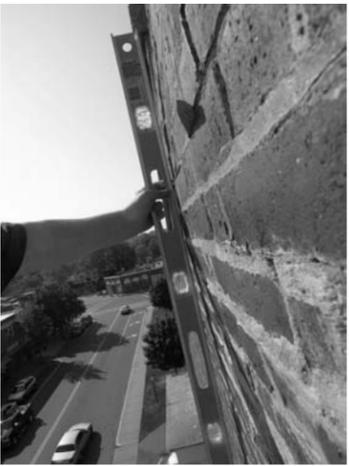
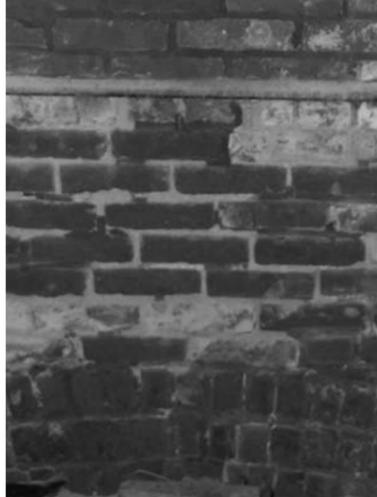
① End Wall Section
1" = 1'-0"

Work shown on these drawings is intended to provide information for stabilization of two bulges in the east wall. Sheets S1 and S3 illustrate existing conditions. Sheets S4 and S5 illustrate stabilization repairs.
